Harada House

3356 Lemon Street, Riverside, California

LONG RANGE CONSERVATION PLAN/HISTORIC STRUCTURE REPORT

January 11, 2007

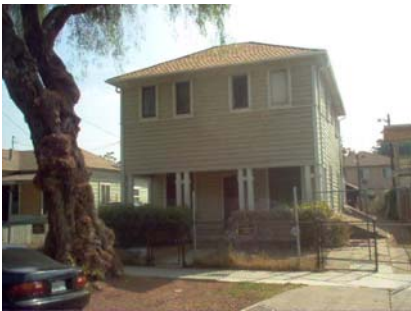
West Elevation
View East

The house is framed in softwood with a brick foundation. The sill above the foundations on the south side is deteriorated due to termites, resulting in some subsidence. The concrete retaining wall on the south basement wall is cracked horizontally and is displaced to the north, probably due to hydrostatic pressure below grade, causing the majority of the subsidence subsequent damage at the south wall. The roof framing has recently been repaired and seismically strengthened on both the single story rear and the main two story volumes. The roofing and gutters were completely replaced by the restoration of wood shakes on original spaced sheathing, and painted galvanized steel sheet metal gutters and leaders that replicate the deteriorated extant elements. The two-story volume's roof is a hipped with a steep pitch and a small deck, while the smaller rear one story section has a moderately pitched gable. The garden shed and the covered former porch on the north side have a single shed low-pitch roof. At the intersection of the wall and the roof there is a wide frieze topped with a quarter-round trim molding. There is a closed eave with a painted wood soffit. The eaves fascia has a profiled crown molding.

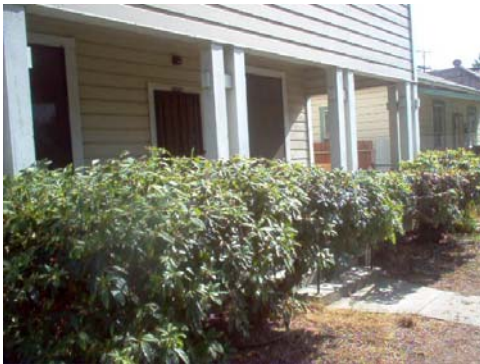
Front Yard

The front yard area is on the west side of the house beginning at the driveway and extending to the lot line on the north side. There is a small area on the north side of the porch that gives an “L” shape to the front yard. The yard is divided by a center concrete walkway that runs from the sidewalk to the steps of the porch. Four large shrubs line the front porch. Two *Pittosporum undulatum* are planted on each side of the walkway at the porch steps framing the entrance. The other two shrubs next to them are *Pittosporum tobria*. These neglected mature shrub plants need immediate care.

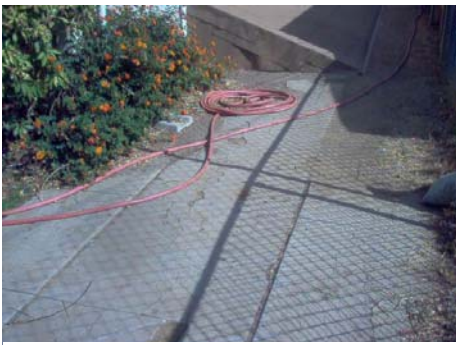
Driveway

Spatial characteristics of the driveway area have changed from the period of significance. The major changes to the area include the removal of the *Schinus molle* (California Pepper) street tree that framed the driveway entrance from the street and the reduced width of clear open space on the driveway side from south property line. Part of the open space on the south is covered by a “cricket” to conduct water away from the basement wall; the plants in this area consisted of overgrown cannas and weeds. The area is important as it was a special area of use for the Harada’s during the period of significance and is mentioned here as a preface for future treatment recommendation.

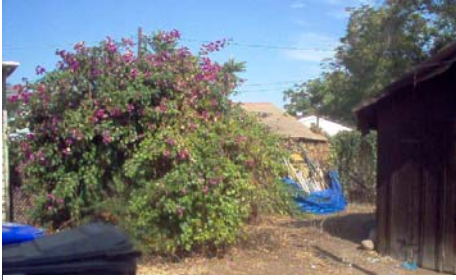
Back Yard

The area to the north of the garage includes some elements from the period of significance. A deteriorating wooden walkway that lines up with the back door and continues to the back fence may be from the period of significance. An aging wooden arbor overtaken by a *Bougainvillea sp.*, with a *Rosa sp.* intertwined is not from the period of significance. This tree was removed in September, 2006, by the City of Riverside. The *Ipomoea tricolor* (morning glory) running wild throughout the backyard area is from the period of significance. Missing from the period of significance is the lattice styled fence.

The south side of the garage has a well-established windblown young *Ailanthus altissima* (Tree of Heaven) seedling. All plants in this area are weed plants obviously windblown species that have taken root in the last ten years. The City of Riverside removed these plants in September 2006.

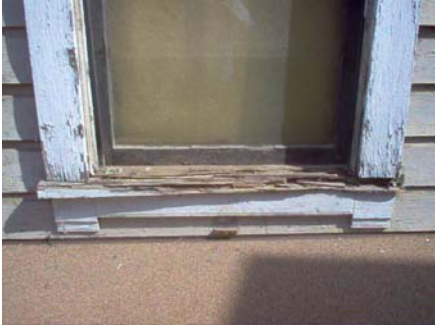
Termite Damaged Sill on the South Elevation

Buildings with wood features exhibit the following conditions which may require maintenance and rehabilitation: repair of deteriorating material; sealing or painting, eaves, or trim due to weathering, water damage, fungal or insect damage.

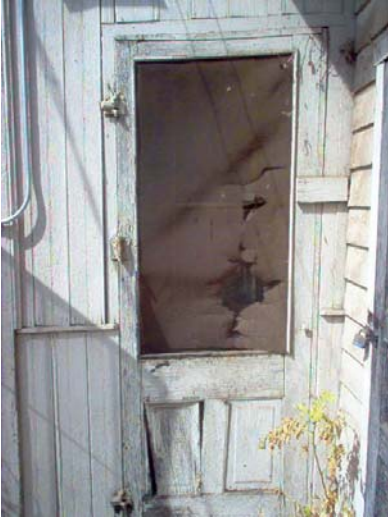
Heavily Damaged Exterior Door on East Elevation

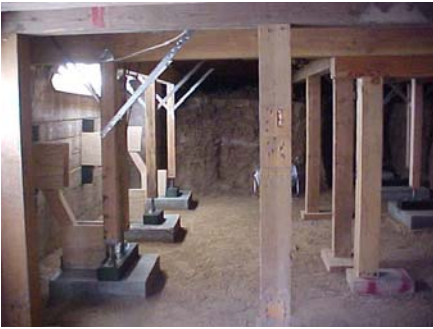
Shoring the Basement

Guidelines for Structural and Mechanical Systems:
