City of Riverside Public Works Department

Update of the Integrated Master Plan for the Wastewater Collection and Treatment Facilities

APPENDIX 7C: ACORN/ARLANZA TRUNK SEWER ANALYSIS

FINAL | June 2019

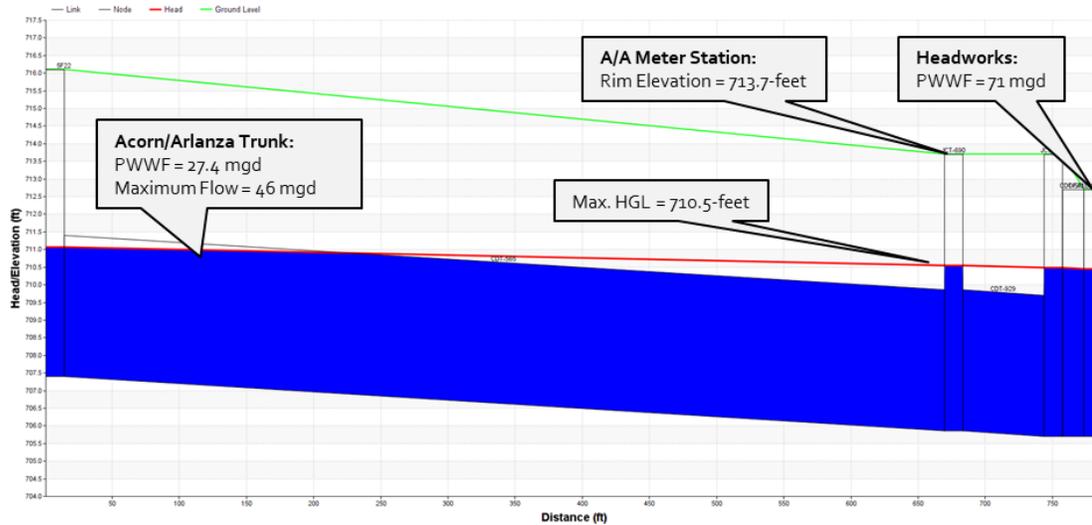
Figure 4 A/A Trunk Sewer HGL under existing PWWF Conditions

The capacity analysis performed for Volume 3, Chapter 7, Capacity Evaluation and Proposed Improvements, of the update to the Master Plan indicated that the A/A Trunk Sewer exceeded the maximum HGL at 90 percent of the pipe diameter (maximum d/D greater than 0.9). Figure 4 shows the HGL profile of the A/A trunk sewer under existing PWWF conditions.

Even though the A/A Trunk Sewer exceeded 90 percent capacity, this did not mean it was deficient. In this case, a surcharged condition within a given pipeline was due to backwater effects created by HGL conditions at the headworks.

The modeling software used to develop the hydraulic model, InfoSWMM, calculates the maximum capacity for every pipe given pipe diameter and slope. In this case, the A/A trunk sewer has a calculated maximum capacity of 46 mgd. However, the meter station surcharges under existing PWWF (roughly 24.7 mgd) conditions (Figure 4). This indicates that the meter station surcharging may be caused by backwater effects created from the hydraulic grade conditions at the RWQCP's headworks. In order to evaluate this further, additional data was requested from the City to confirm how the HGL conditions at the headworks impacts the A/A Trunk Sewer. The additional data was used to revise the hydraulic model to simulate the head conditions at the RWQCP headworks to see if the model would replicate the elevated hydraulic grade observed in the filed by City staff.

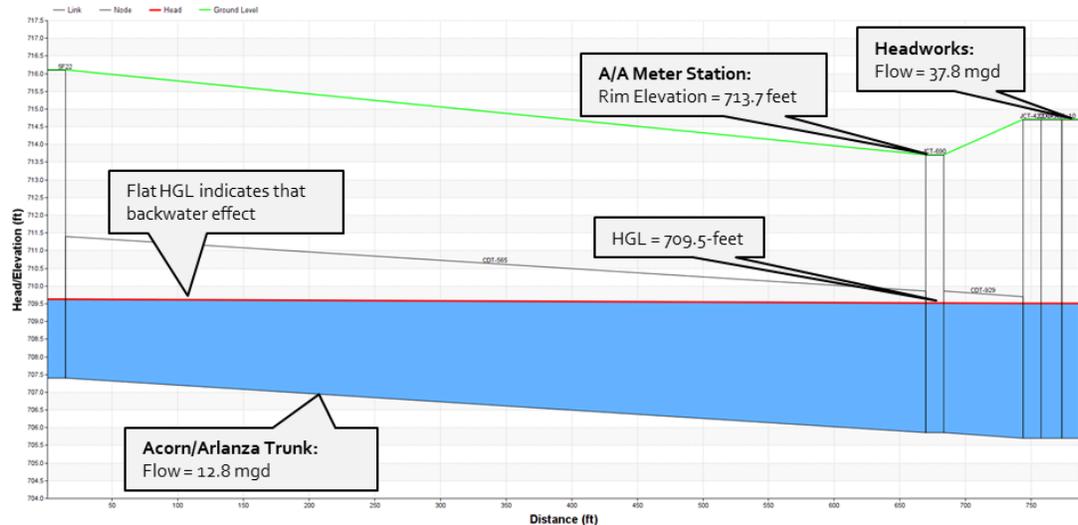
Figure 6 A/A Trunk Sewer HGL at 12.8 mgd

The modeled results at the meter station were compared to the measured depth. Measurements 1 and 2 were used to confirm the updated depth versus flow relationship curve. For each event the measured A/A trunk sewer flow was loaded at the A/A junction structure, while the difference between the measured headworks and A/A trunk sewer flows was loaded upstream along the Santa Ana Sewer Line. The modeled meter box depth matched well to the measured results for measurements 1 and 2. Figure 6 shows the HGL of the A/A trunk sewer with a flow of 12.8 mgd. The level HGL indicates that the backwater effects are caused by the headworks, represented by the outfall in the model. Therefore, the surcharging is a result of the backwater effects caused by the hydraulic grade conditions at the headworks.

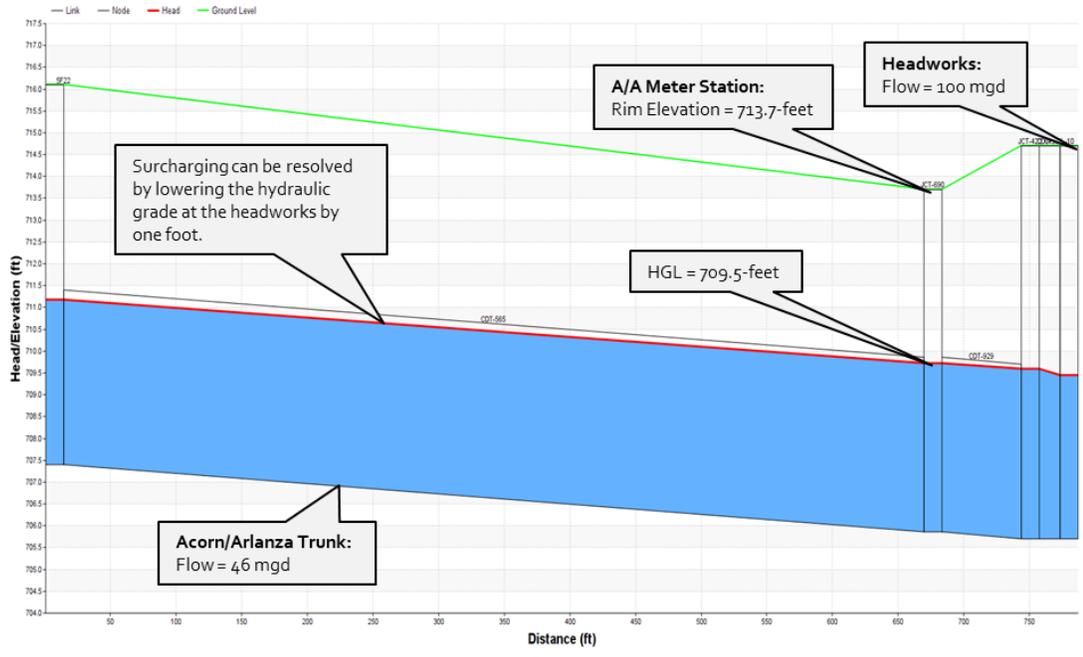
Figure 7 A/A Trunk Sewer HGL at 46 mgd and Headworks Lower by 1-foot

Once the flow depth versus flow curve was confirmed, the model was re-run with a flow of 46 mgd through the A/A trunk sewer and the flow loaded along the Santa Ana Sewer Line was reduced until the A/A trunk sewer no longer experienced surcharge conditions. This approach was unable to produce observed surcharging conditions as seen by City staff in the field. To capture non-surge conditions along the A/A trunk sewer the modeled headworks floor elevation was lowered by 1-foot. Figure 7 shows the A/A trunk sewer's HGL under these assumptions. The HGL profile is no longer flat, but parallel to the trunk sewer. This confirms that the A/A trunk sewer surcharge conditions are caused by downstream boundary conditions. To lower the flow levels in the A/A trunk sewer and avoid the existing surcharge at the metering station, the City would have to lower the HGL conditions at the headworks. The headworks project includes replacing the barscreens with Multirake barscreens, which may lower the upstream HGL a few inches. However, to lower the HGL by a foot will require completely a new headworks and modifications to downstream facilities, which is not included in the current CIP. Up sizing the A/A Trunk will not improve the HGL.

- The hydraulic grade conditions at the headworks will need to be lowered by approximately 1-foot in order to mitigate surcharge conditions along the A/A trunk sewer.

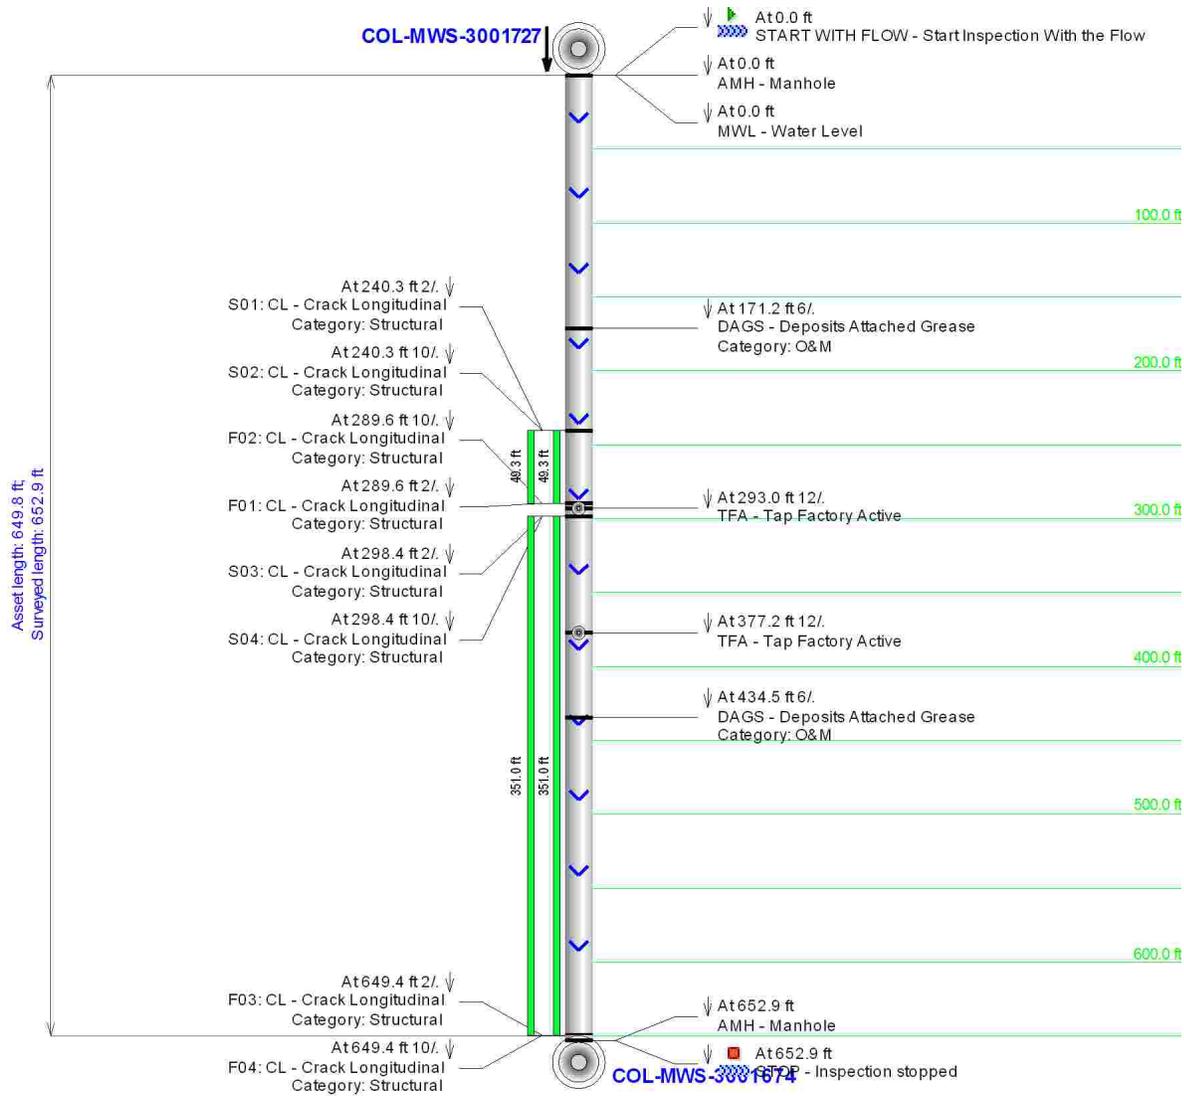
Project Name: RWQCP		Pipeline segment ref: COL-PMWS-3002934		City: RIVERSIDE, CA		Street: ACORN ST	
Start date/time: 1/4/2018		Width: 27		Material: VCP		Location code:	
Direction: Downstream		Length surveyed: 652.9		Weather:		Media label:

Footage	Rev.	Length	Clock From	Clock To	Code	Modifiers/Severity	Rating
0.0	No				START WITH FLOW		
0.0	No				AMH		
0.0	No				MWL		
171.2	No		6		DAGS		
240.3	No		2		CL		
240.3	No		10		CL		
289.6	No		10		CL		
289.6	No		2		CL		
293.0	No		12		TFA		
298.4	No		2		CL		
298.4	No		10		CL		
377.2	No		12		TFA		
434.5	No		6		DAGS

Footage	Rev.	Length	Clock From	Clock To	Code	Modifiers/Severity	Rating
649.4	No			2	CL		
649.4	No			10	CL		
652.9	No				AMH		
652.9	No				STOP

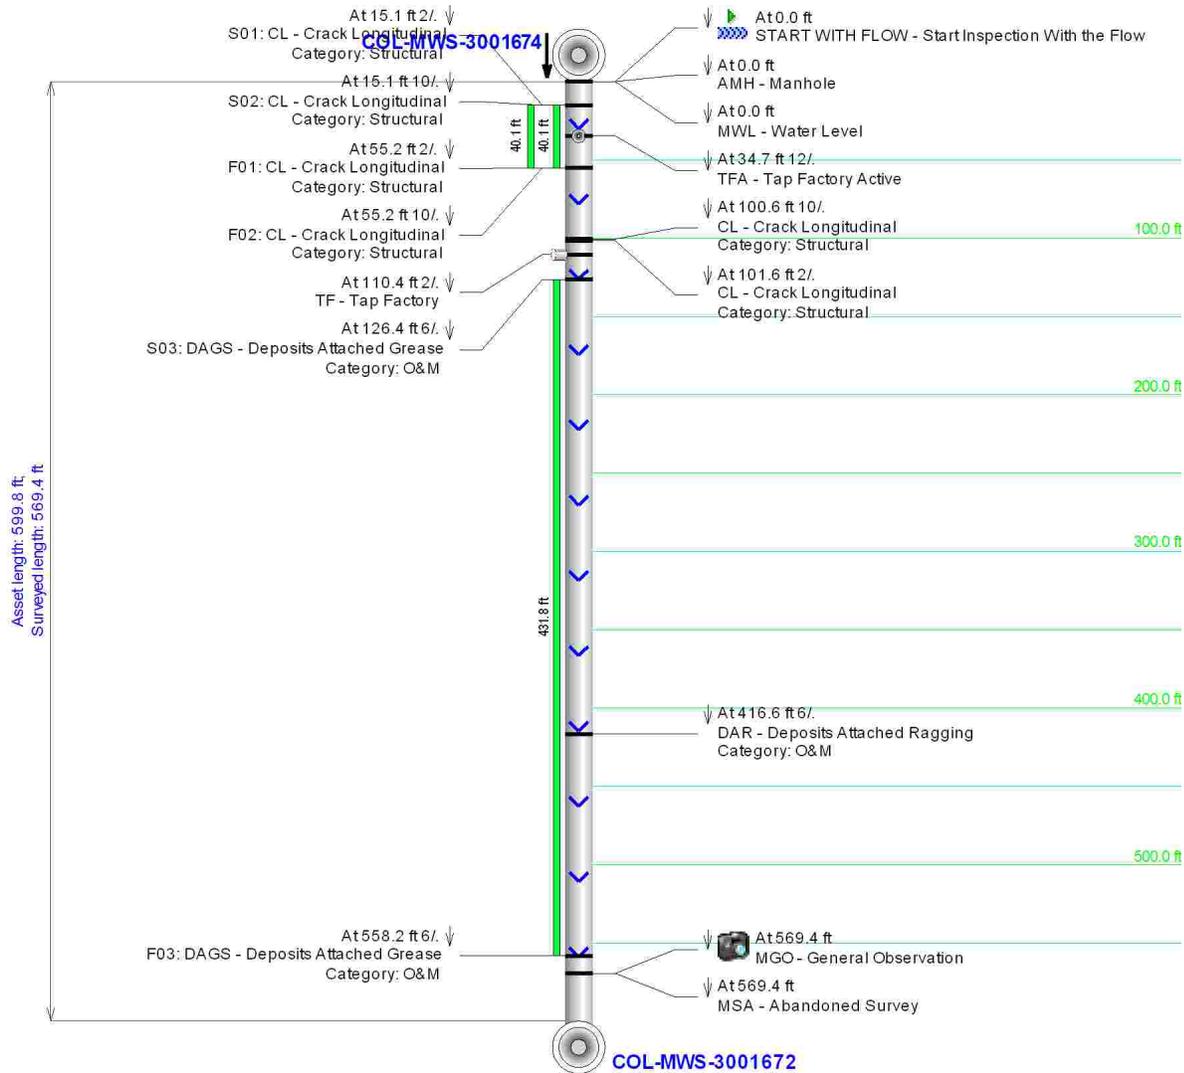
Project Name: RWQCP	Pipeline segment ref: COL-PWS-3003363	City: RIVERSIDE, CA	Street: ACORN ST
Start date/time: 1/5/2018	Width: 27	Material: VCP	Location code:
Direction: Downstream	Length surveyed: 569.4	Weather:	Media label:

Footage	Rev.	Length	Clock From	Clock To	Code	Modifiers/Severity	Rating
0.0	No				START WITH FLOW		
0.0	No				AMH		
0.0	No				MWL		
15.1	No		2		CL		
15.1	No		10		CL		
34.7	No		12		TFA		
55.2	No		2		CL		
55.2	No		10		CL		
100.6	No		10		CL		
101.6	No		2		CL		
110.4	No		2		TF		
126.4	No		6		DAGS		
416.6	No		6		DAR

Footage	Rev.	Length	Clock From	Clock To	Code	Modifiers/Severity	Rating
558.2	No			6		DAGS	
569.4	No					MGO	
569.4	No					MSA

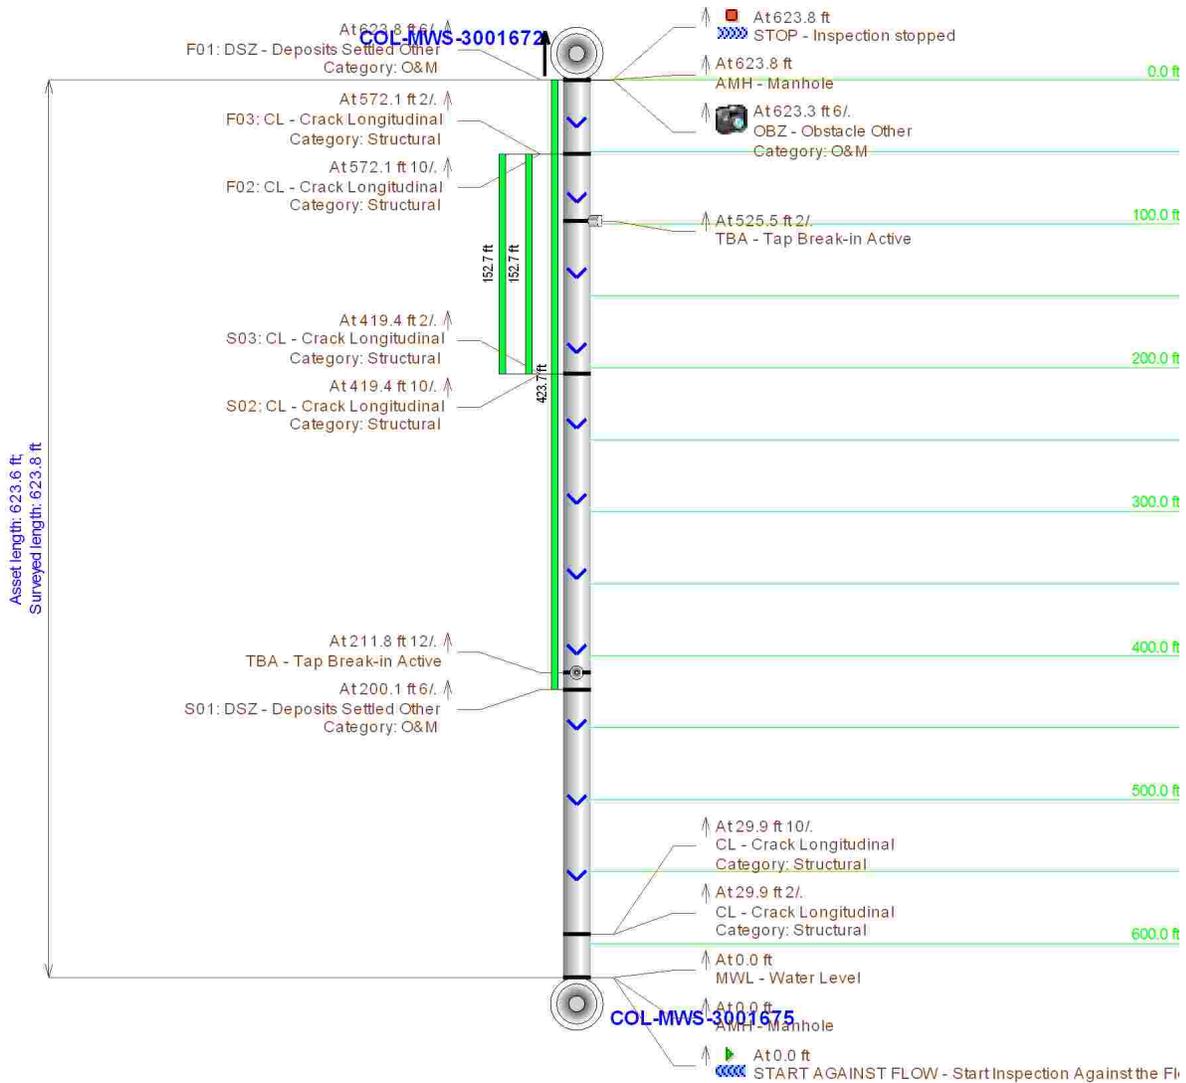
Project Name:	Pipeline segment ref:	City:	Street:
RWQCP	COL-PWS-3003725	RIVERSIDE, CA	ACORN ST
Start date/time:	Width:	Height:	Material:
1/5/2018		27	VCP
Location code:	Direction:	Length surveyed:	Weather:
	UPSTREAM	623.8	
Media label:

Footage	Rev.	Length	Clock From	Clock To	Code	Modifiers/Severity	Rating
0.0	Yes				START AGAINST FLOW		
0.0	Yes				AMH		
0.0	Yes				MWL		
29.9	Yes		2		CL		
29.9	Yes		10		CL		
200.1	Yes		6		DSZ		
211.8	Yes		12		TBA		
419.4	Yes		10		CL		
419.4	Yes		2		CL		
525.5	Yes		2		TBA		
572.1	Yes		10		CL		
572.1	Yes		2		CL		
623.3	Yes		6		OBZ

Footage	Rev.	Length	Clock From	Clock To	Code	Modifiers/Severity	Rating
623.8	Yes			6	DSZ		
623.8	Yes				AMH		
623.8	Yes				STOP

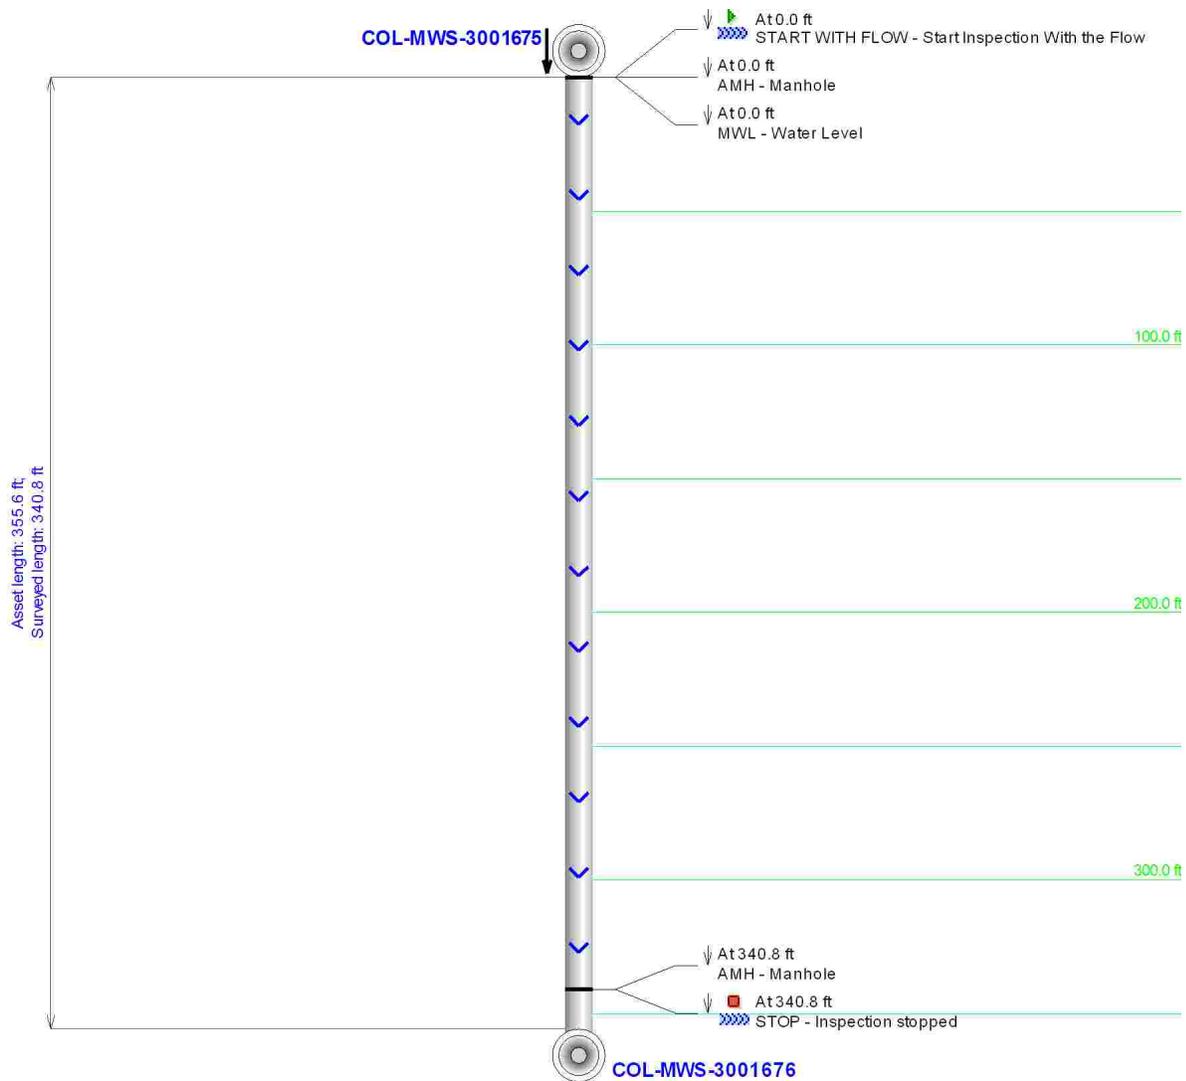
Project Name: RWQCP	Pipeline segment ref: COL-PWS-3004096	City: RIVERSIDE, CA	Street: ACORN ST
Start date/time: 1/5/2018	Width: 	Height: 27	Material: VCP
Location code: 	Direction: Downstream	Length surveyed: 340.8	Weather:
			Media label:

Footage	Rev.	Length	Clock From	Clock To	Code	Modifiers/Severity	Rating
0.0	No				START WITH FLOW		
0.0	No				AMH		
0.0	No				MWL		
340.8	No				AMH		
340.8	No				STOP

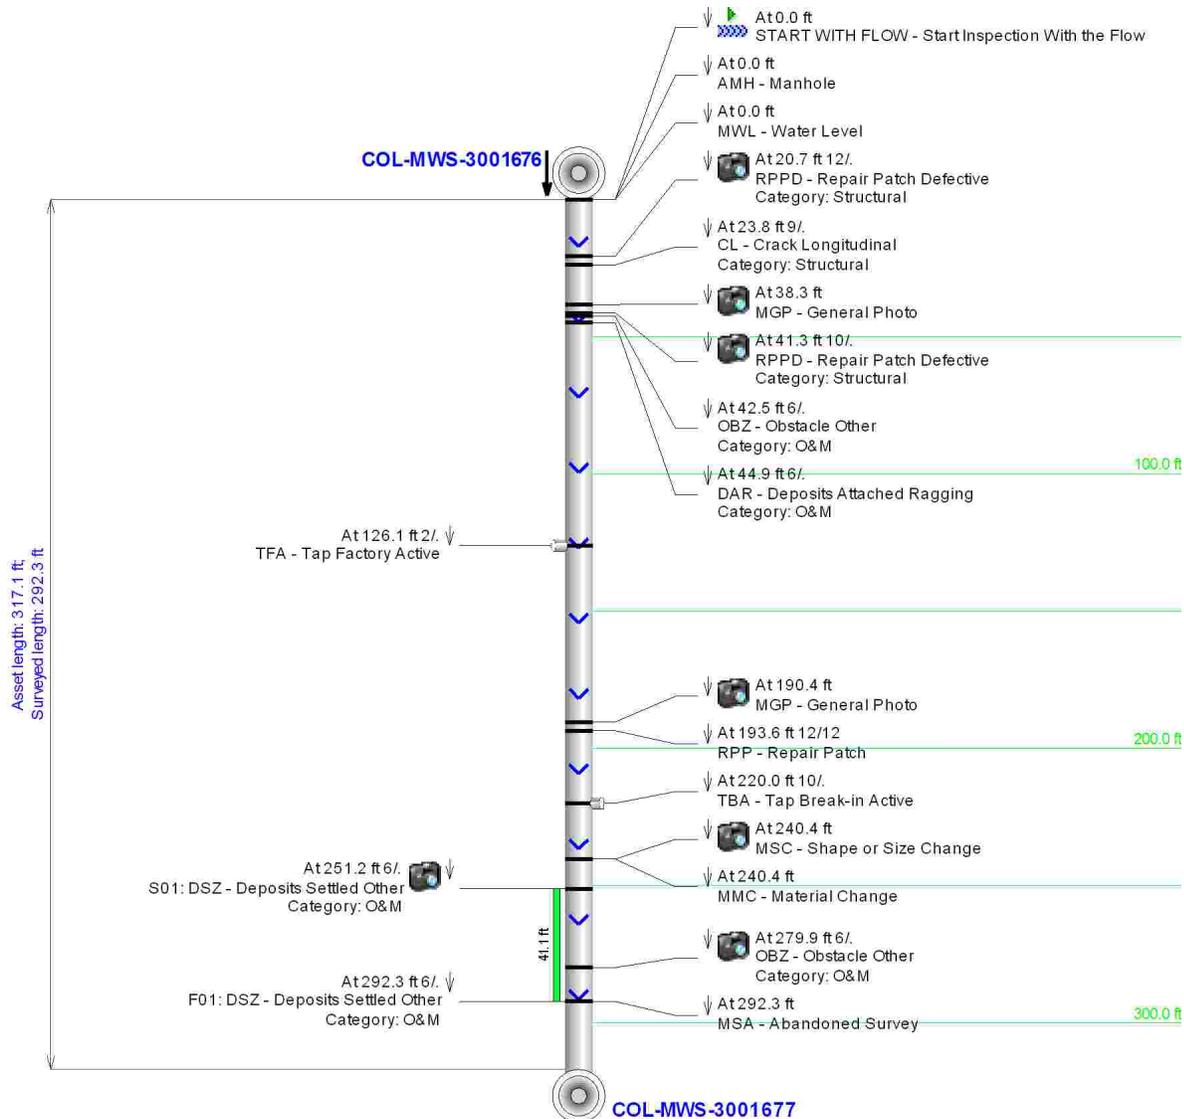
Project Name: RWQCP	Pipeline segment ref: COL-PWS-3004214	City: RIVERSIDE, CA	Street: RWQCP
Start date/time: 1/5/2018	Width: 	Height: 27	Material: VCP
Location code: 	Direction: Downstream	Length surveyed: 292.3	Weather:
		Media label:

Footage	Rev.	Length	Clock From	Clock To	Code	Modifiers/Severity	Rating
0.0	No				START WITH FLOW		
0.0	No				AMH		
0.0	No				MWL		
20.7	No		12		RPPD		
23.8	No		9		CL		
38.3	No				MGP		
41.3	No		10		RPPD		
42.5	No		6		OBZ		
44.9	No		6		DAR		
126.1	No		2		TFA		
190.4	No				MGP		
193.6	No		12	12	RPP		
220.0	No		10		TBA

Footage	Rev.	Length	Clock From	Clock To	Code	Modifiers/Severity	Rating
240.4	No				MSC		
240.4	No				MMC		
251.2	No		6		DSZ		
279.9	No		6		OBZ		
292.3	No		6		DSZ		
292.3	No				MSA

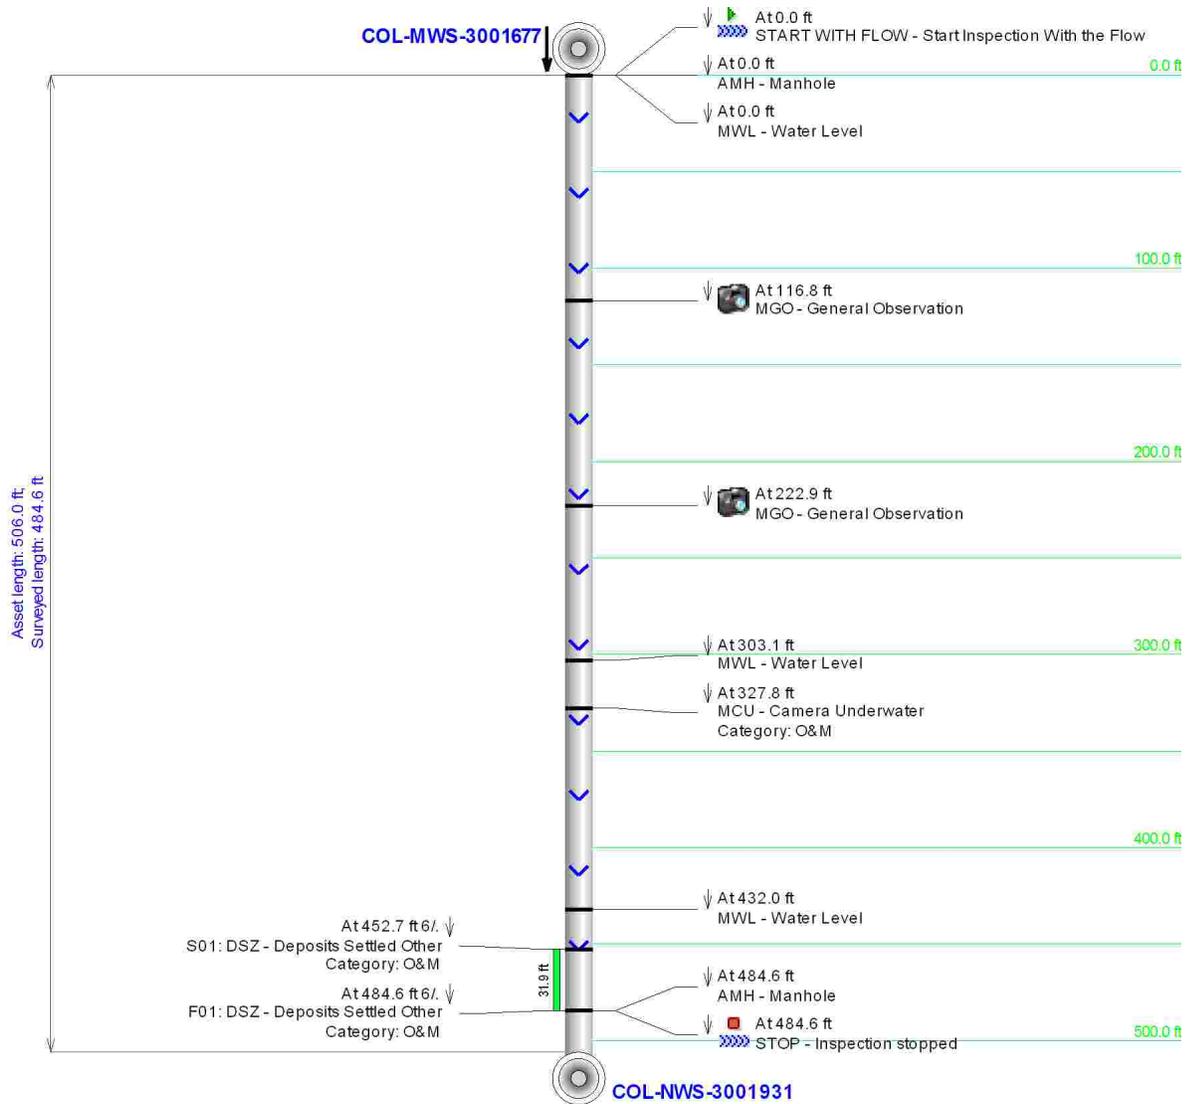
Project Name: RWQCP	Pipeline segment ref: COL-PWS-3004358	City: RIVERSIDE, CA	Street: RWQCP
Start date/time: 1/5/2018	Width: 	Height: 47	Material: XXX
Location code: 	Direction: Downstream	Length surveyed: 484.6	Weather:
Media label:

Footage	Rev.	Length	Clock From	Clock To	Code	Modifiers/Severity	Rating
0.0	No				START WITH FLOW		
0.0	No				AMH		
0.0	No				MWL		
116.8	No				MGO		
222.9	No				MGO		
303.1	No				MWL		
327.8	No				MCU		
432.0	No				MWL		
452.7	No		6		DSZ		
484.6	No		6		DSZ		
484.6	No				AMH		
484.6	No				STOP
