**PHASE I PALEONTOLOGICAL RESOURCES ASSESSMENT
TENTATIVE TRACT MAP 38094 PROJECT
CITY OF RIVERSIDE, RIVERSIDE COUNTY, CALIFORNIA**

***Revised September 2021* March 2021**

Type of Study: Paleontological resources assessment

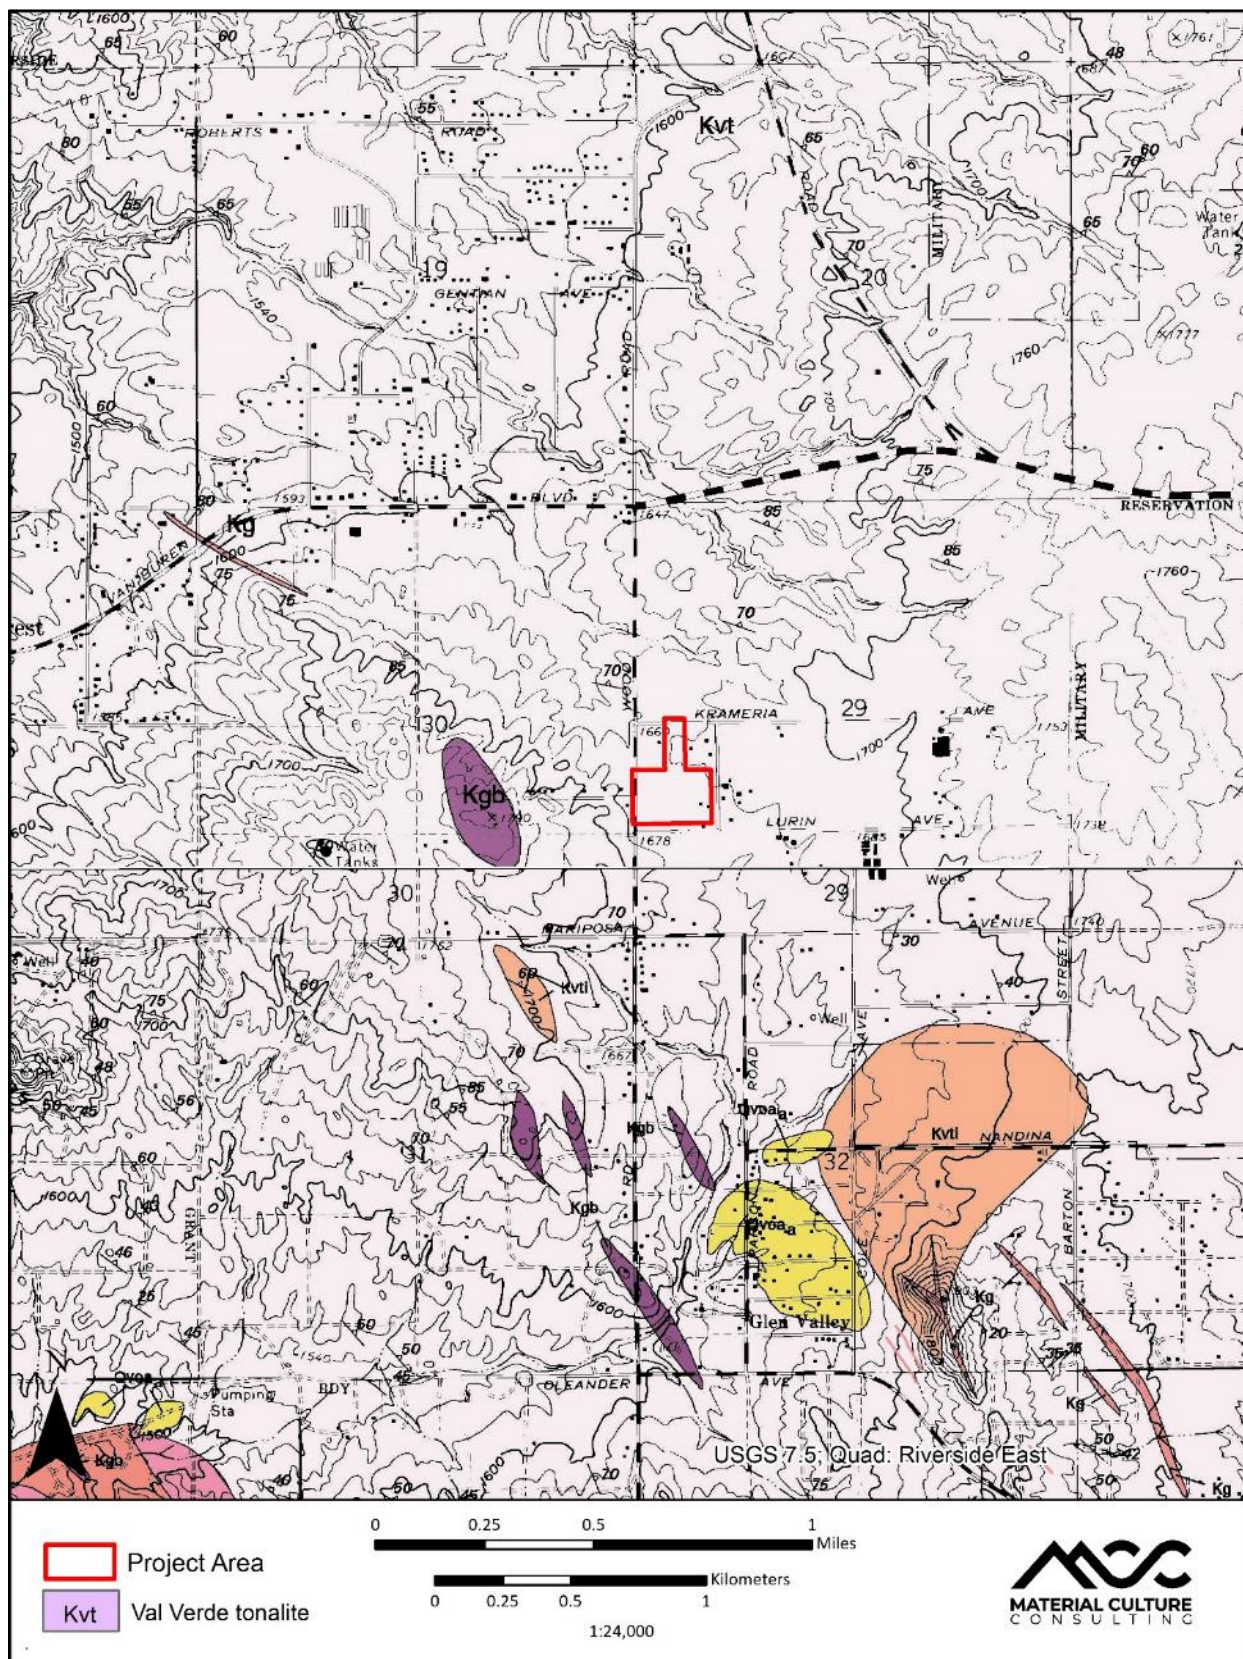
Figure 4. Tentative Tract Map 38094 Geologic Map (from Morton and Cox 1988)

Val Verde tonalite (Kvt) is a gray-weathering, relatively homogeneous, massive- to well-foliated, medium- to coarse-grained, hypautomorphic-granular biotite-hornblende tonalite; it is the primary rock type of the Val Verde pluton. It contains some biotite and hornblende, quartz and plagioclase (Morton and Cox 1988). This rock unit, due to its formation deep underground from a magmatic source, is not fossiliferous and has a low paleontological sensitivity. It is overlain by a thin veneer of Recent sediments; however, these sediments are extensively reworked by agricultural earthmoving and are unlikely to contain any in-situ fossils.

The *Riverside East* quadrangle lies in the northern part of the Peninsular Ranges geomorphic province, within the central part of the Perris Block. The Perris Block is a structurally stable, internally cohesive mass of crustal rocks bounded on the east by the San Jacinto fault zone, bounded on the west by the Elsinore and Chino fault zones, on the north by the Cucamonga fault zone (Morton and Matti 1989; Morton and Cox 1988), and on the south by a series of sedimentary basins (Morton and Matti 1989). The quadrangle is underlain predominately by Cretaceous plutonic rocks, a part of the Peninsular Ranges batholith complex (Morton and Cox 1988). Batholithic rocks represent a wide range of mafic to intermediate composition rocks in this unit, ranging from diorite and granite to tonalite (Morton and Cox 1988). Specifically, the Project Area is mapped as lying within the Val Verde tonalite (Kvt) (Morton and Cox 1988, Figure 4). The principal rock type of Val Verde pluton outcrops here, consisting of gray, medium to coarse-grained tonalite.

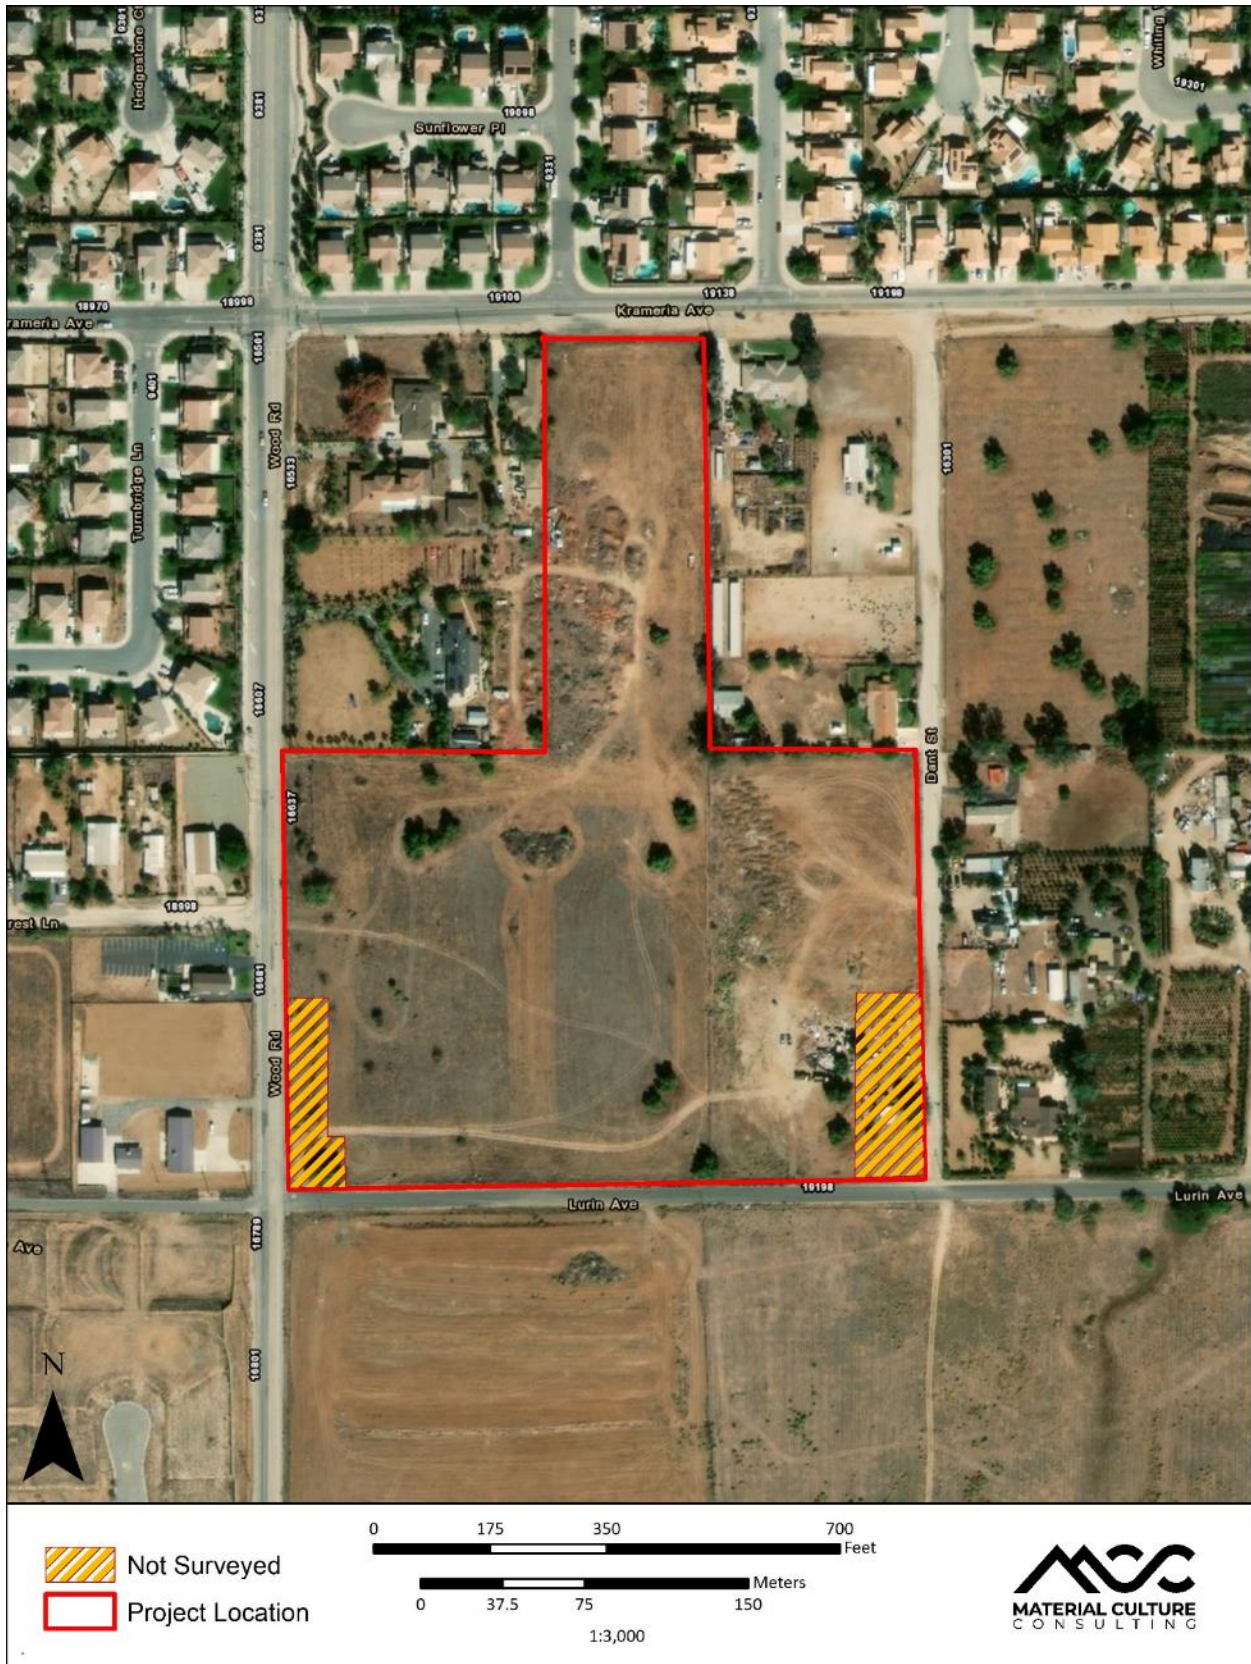
Figure 6. Survey results map (1:3,000, as depicted on aerial photograph)

During the course of fieldwork, survey conditions were good (Figures 7 through 22). Ground visibility in the entire Project Area ranged from poor to excellent (5-90%) due to density of overgrown grass and weeds. The average surface visibility was good (75%). The eastern and northwestern portion of the Project Area had lowered visibility (5-25%). Areas with poorer visibility were surveyed in 5-meter transects instead of 10-meter transects. Presently, the Project Area exists as a grassy field with a gradual west-facing slope of less than 10-degrees. Construction on Wood Road was taking place. A portion (approximately 0.43 acres) of the Project on the western boundary was being used by the construction crew. The area had some equipment, machinery, work vehicles, and construction material. A residential home was present in southeast corner of Lurin Avenue and Dant Street. The area around the active construction site and the immediate area around the home and the house itself was not surveyed (Figure 6).

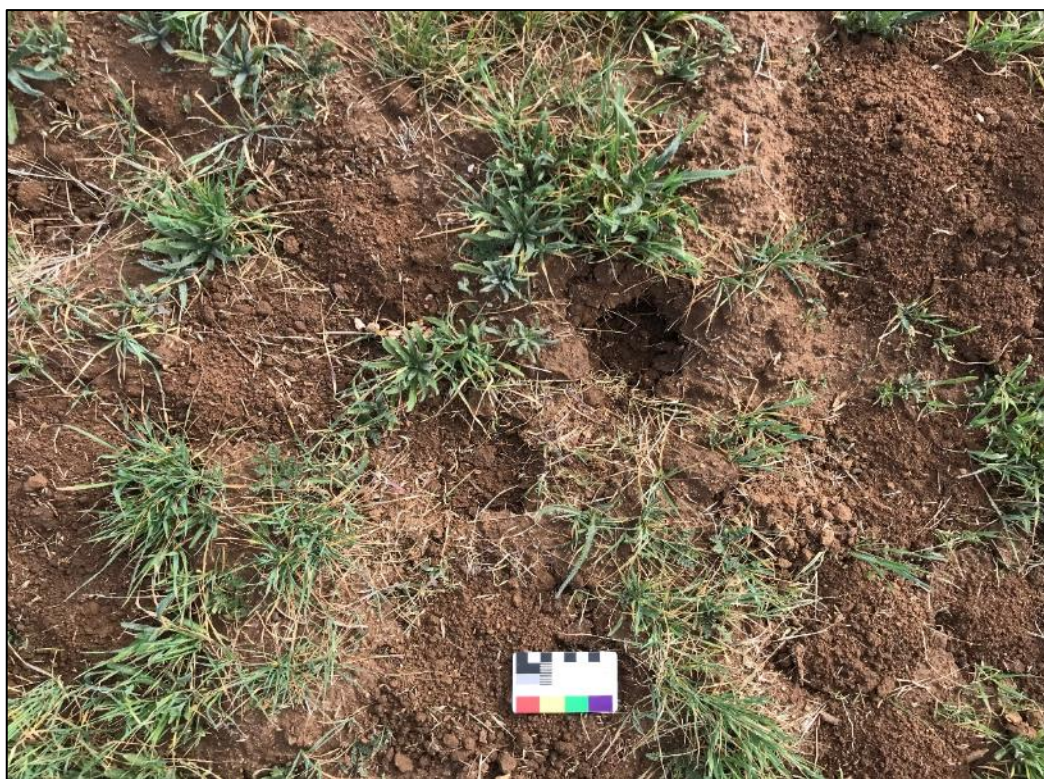
Figure 8. Representative photograph of soil from western portion of Project Area, plan view

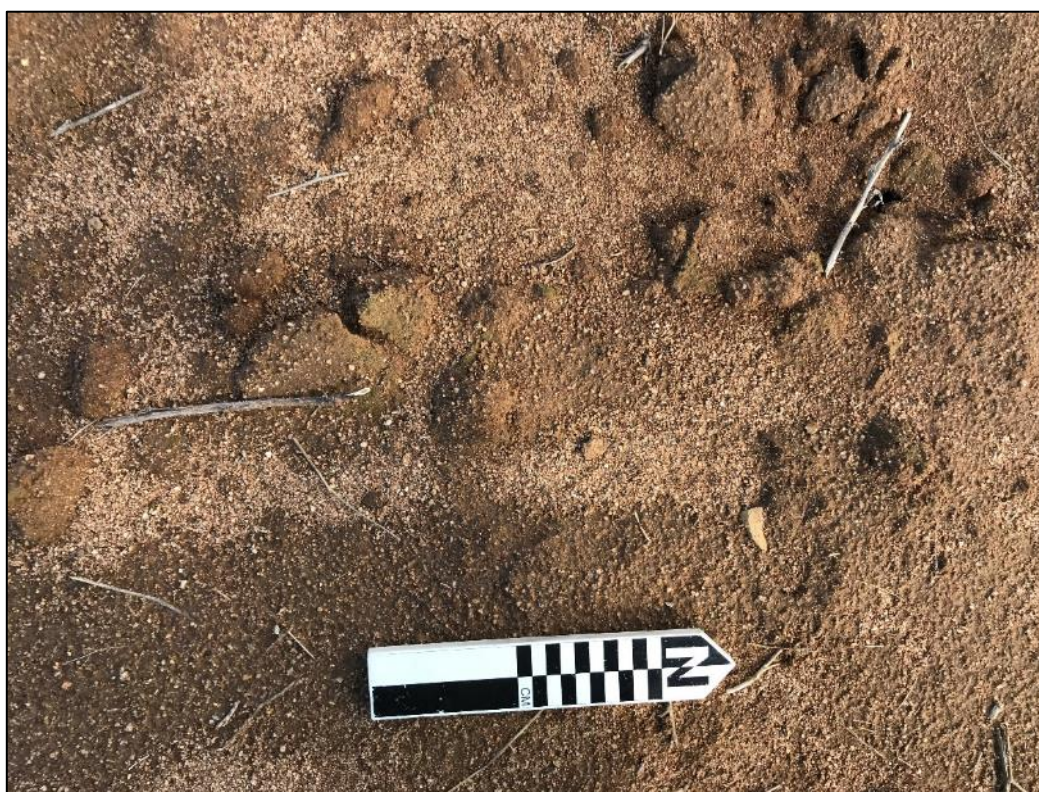
Figure 10. Representative photo of coarse-grained sandy loam in central portion of Project Area, plan view

Overall, the Project Area is highly disturbed. Evidence of construction vehicles and agricultural machinery was observed throughout the Project Area. Disking by machinery looks to have taken place recently as evident by overturned soil. Piles of cut trees were present in the northernmost portion. In addition, remnants of a modern irrigation system was observed. Multiple dirt roads are located throughout the Project area, including in the northern portion of the Project Area leading from the area to residential homes outside of the Project. Modern dumping was also observed throughout the Project Area, including building materials and concrete foundation. Soil in the area consisted of brown fine to coarse-grained sandy loam with pebble to small boulder inclusions of gray granitic-tonalitic material and quartz material. The sediments present may be imported at one time to improve the soil conditions of the orchard (Figures 10 and 11). No paleontological resources were observed during the field survey.

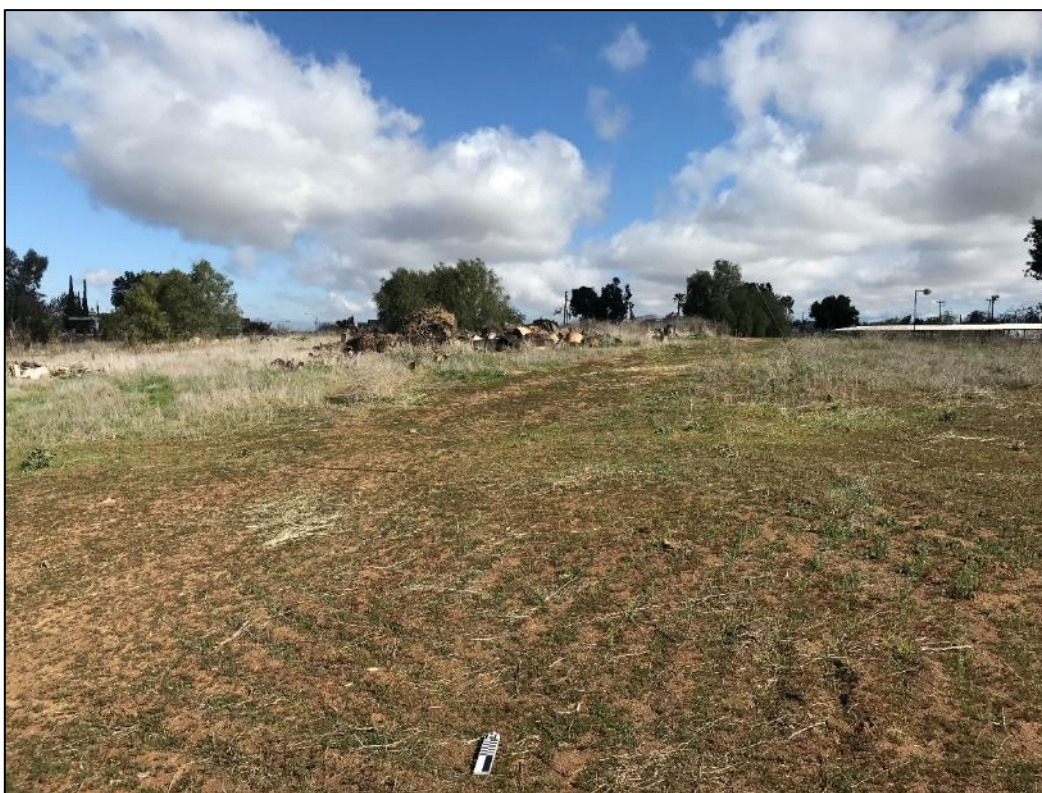
Figure 12. Project overview of northern portion with chopped wood pile in background, view north

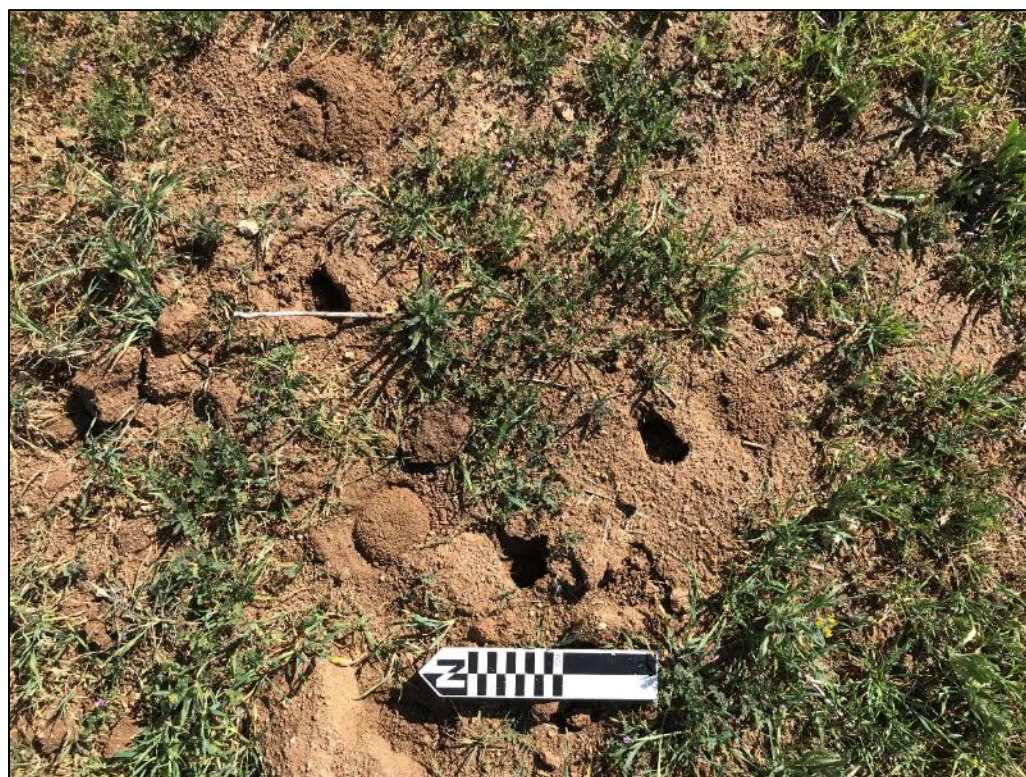
Figure 14. Representative photograph of soil from northern portion of Project Area, plan view

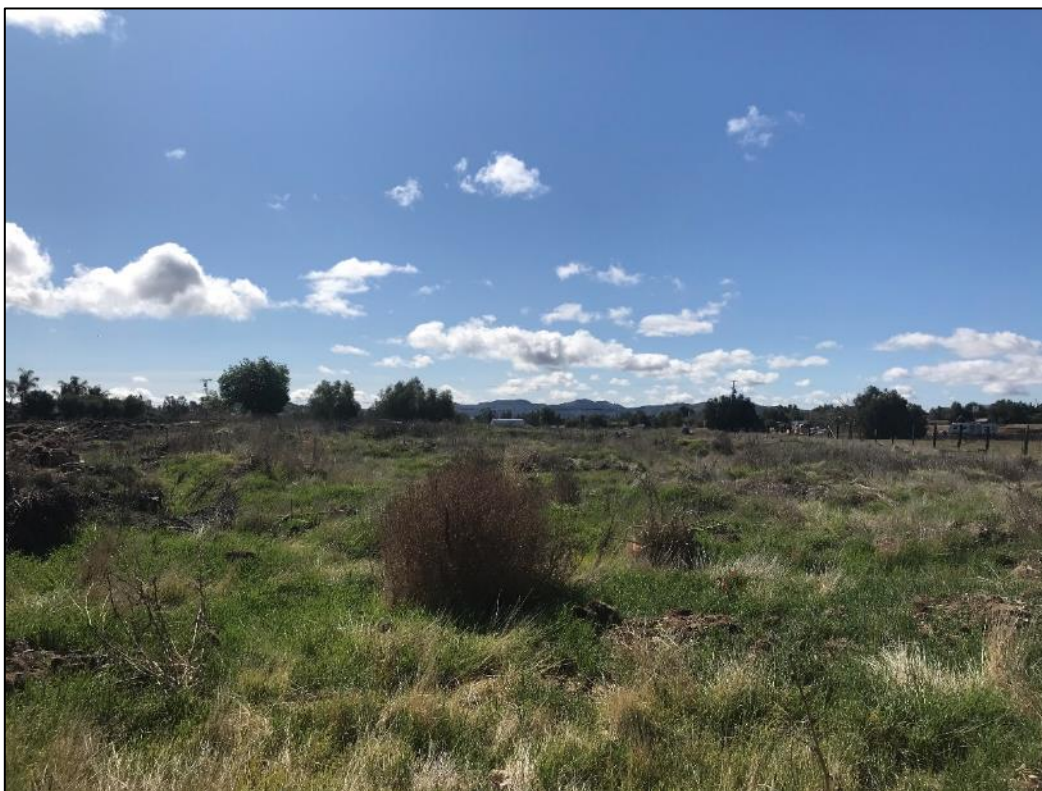
Figure 15. Project overview of eastern portion with low visibility, view south

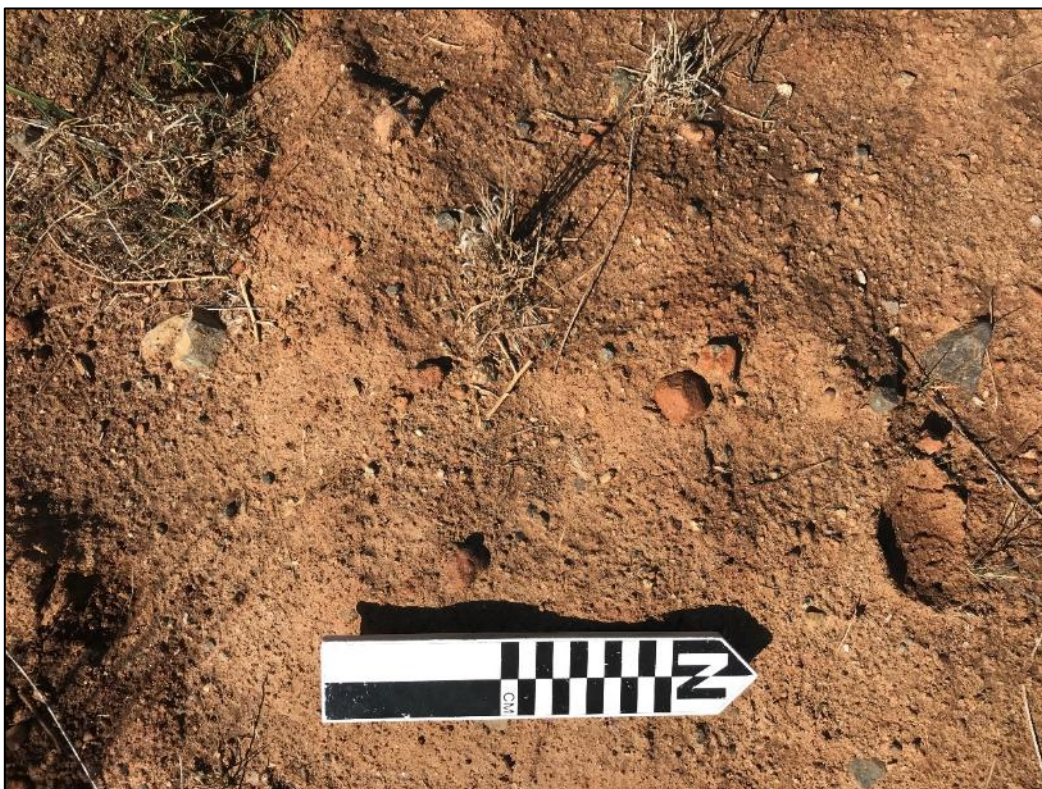
Figure 17. Representative photograph of reddish-brown, coarse-grained sandy loam with granitic inclusions in eastern portion, plan view

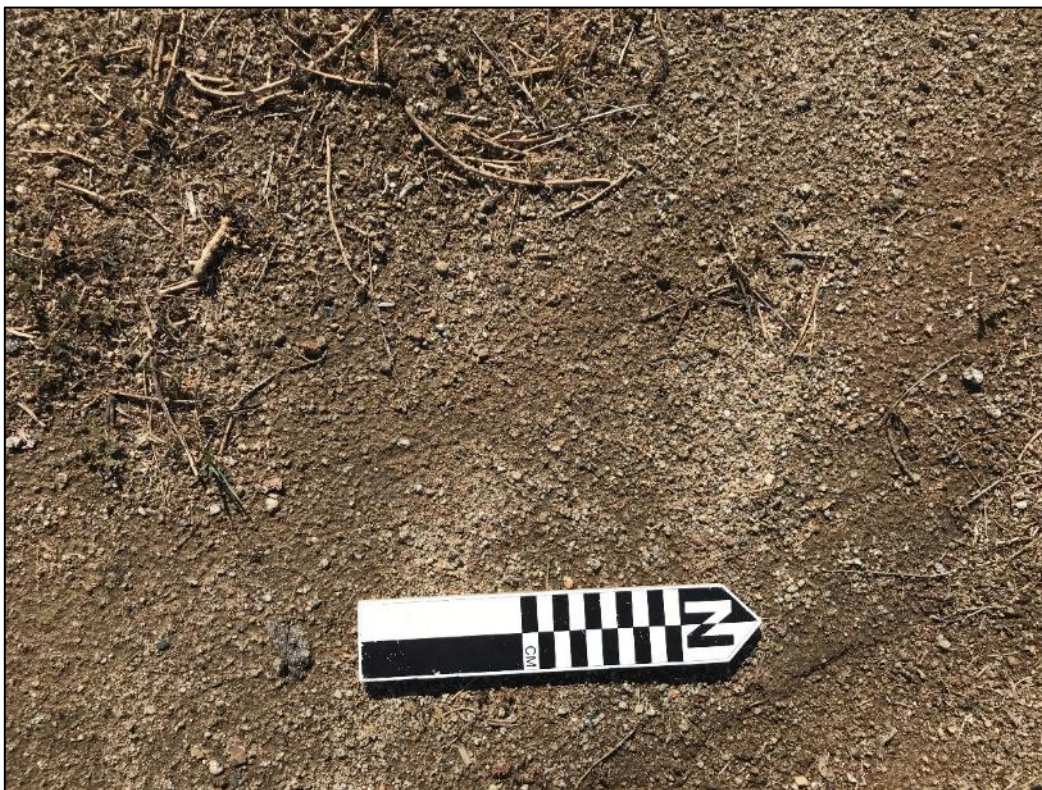
Figure 18. Representative photograph of brown, coarse-grained sandy loam with granitic inclusions in eastern portion, plan view

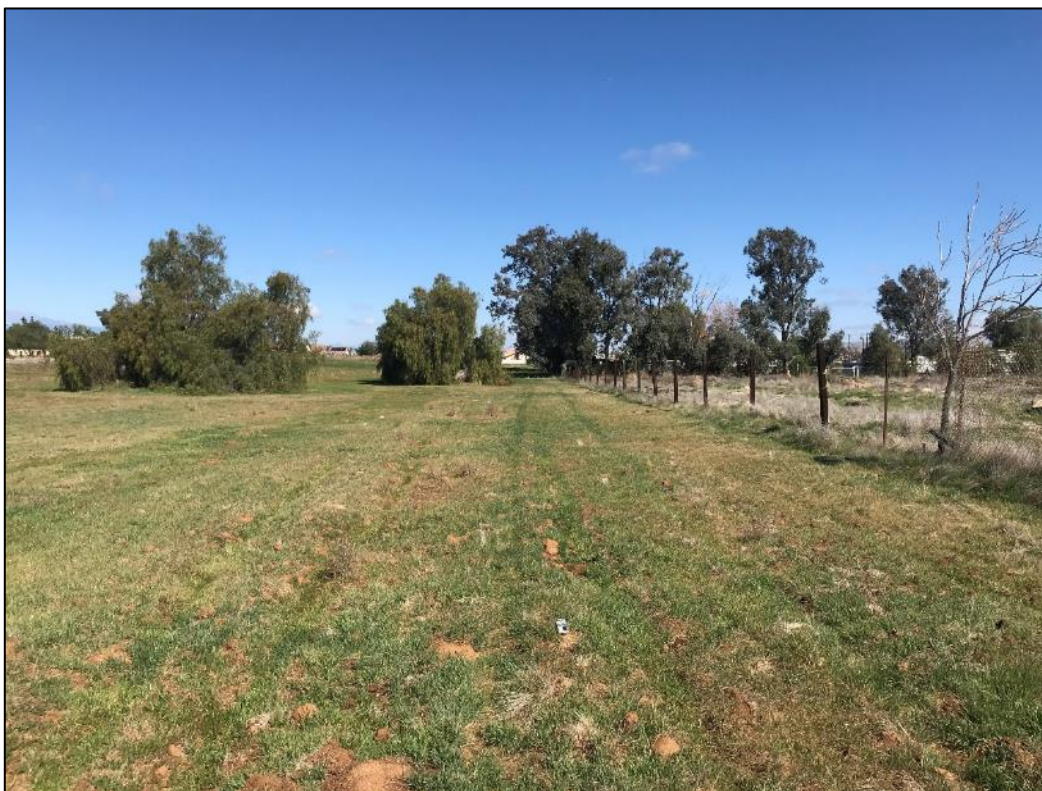
Figure 21. Representative photograph of mowing disturbance, view north

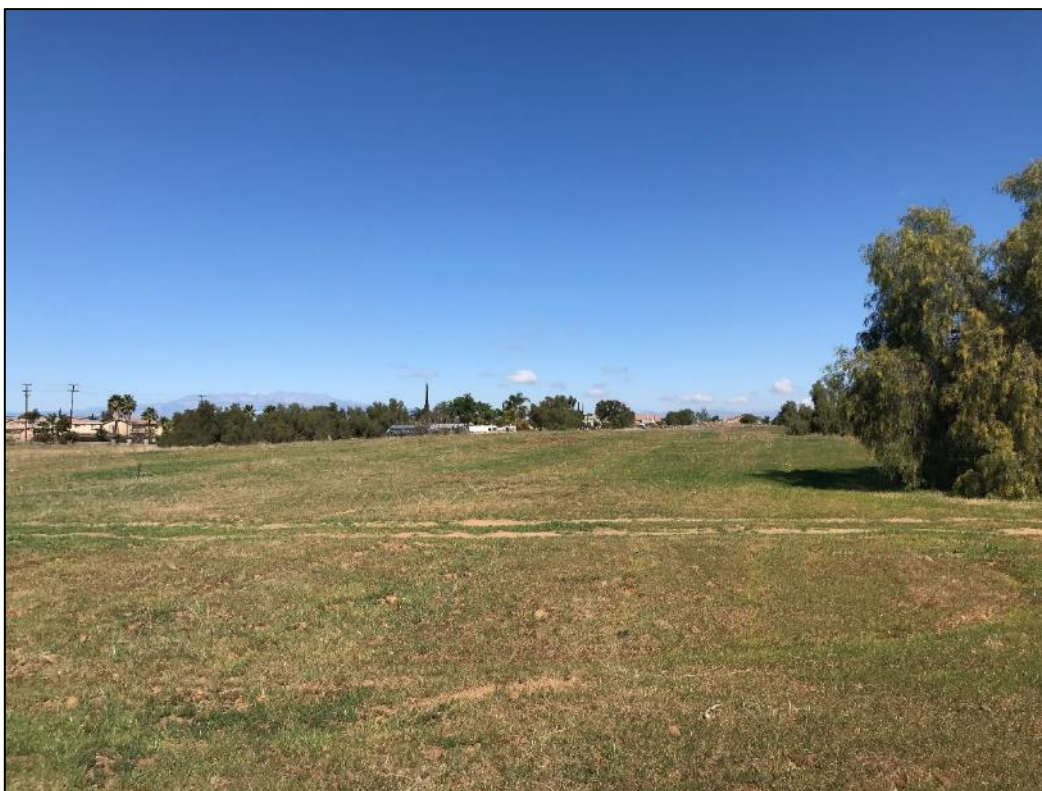
Figure 22. Representative photograph of dirt access road in Project Area, view north
