**LIMITED PHASE II ENVIRONMENTAL  
SITE ASSESSMENT**

Former Moose Lodge  
8627 Philbin Avenue and  
5731, 5741, 5761, and 5797 Picker Street  
Riverside, California

**Converse Project No. 07-16-122-02**

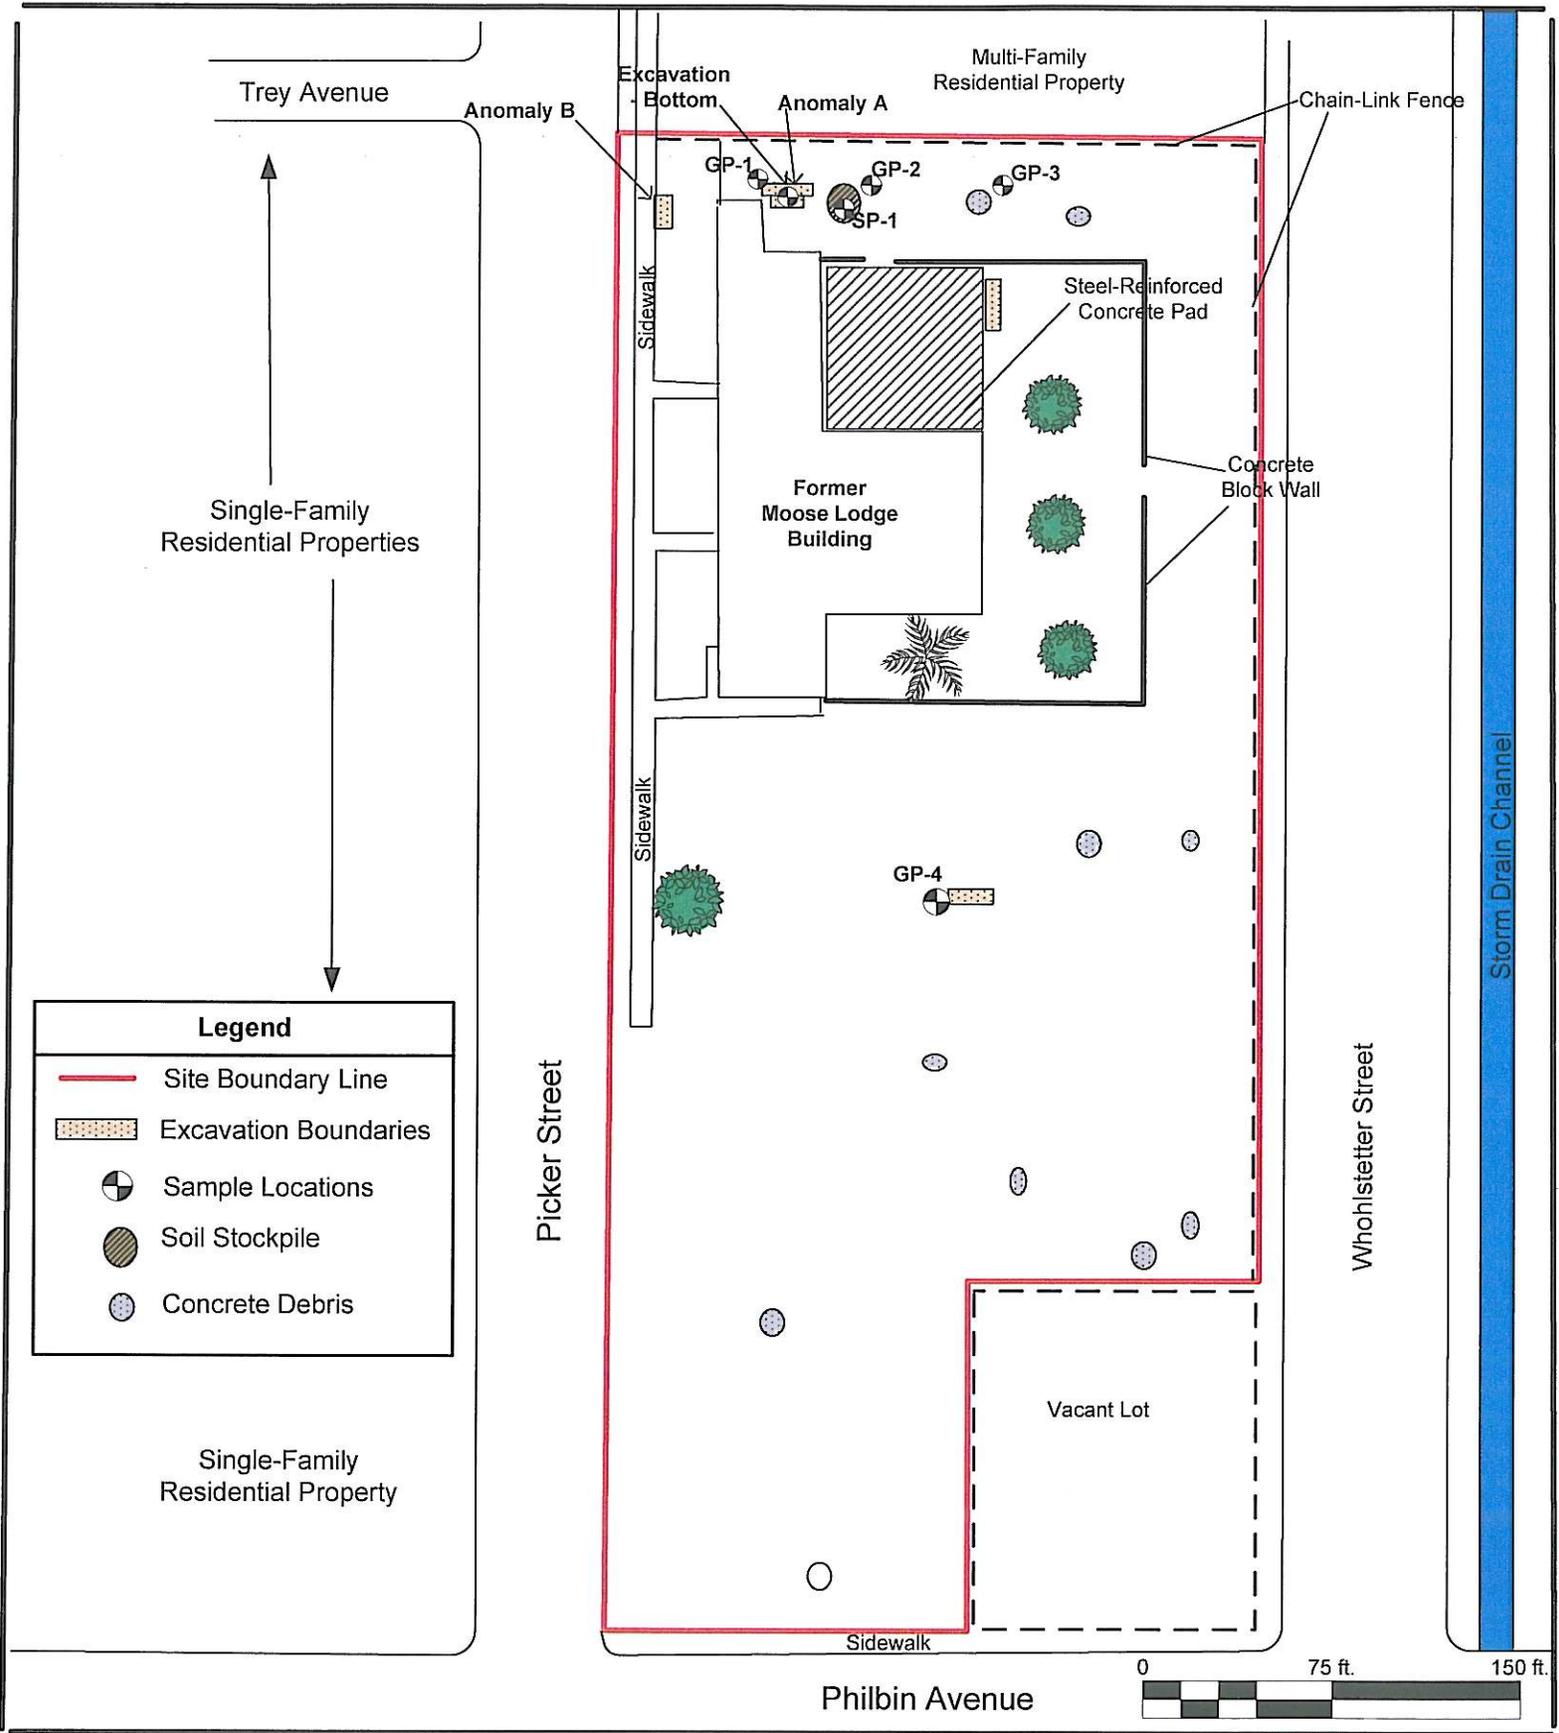
**Boring, Trench, And Sample Location Map**

A field generated, scaled map showing approximate trench, boring, and sample locations is included as an attachment (Figure 2). Photographic documentation is included in Appendix C.

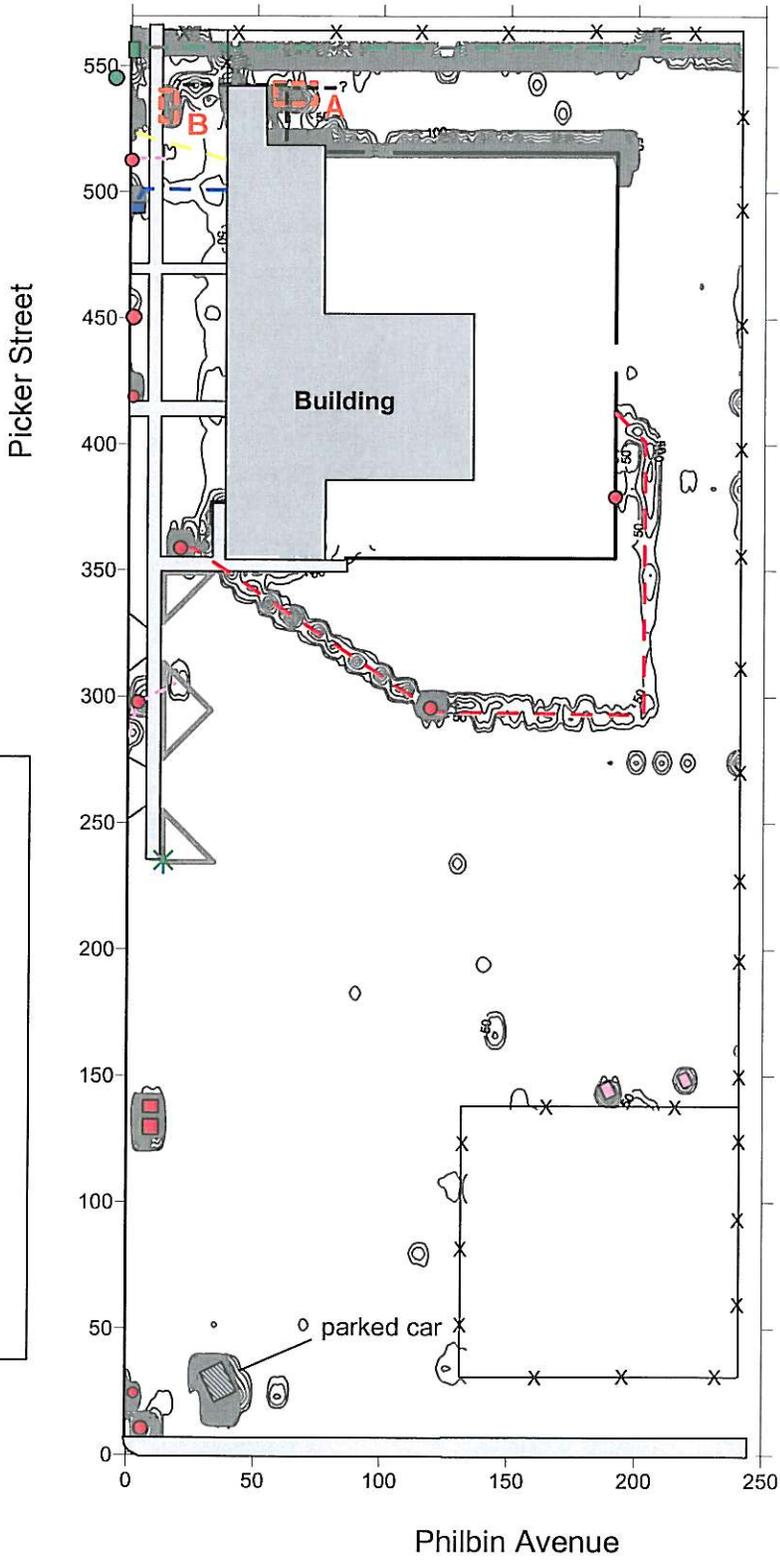
Figure 2

As previously discussed, the purpose of our evaluation was to assess the presence of buried underground storage tanks (USTs). During the course of our survey the geophysical data indicated the presence of two EM anomalies, denoted as anomalies A and B on Figures 2 and 3. The magnitude of the EM responses is similar to that of a small UST; however, the areal extent of these features especially Anomaly B is relatively small. Anomaly A is located at an intersection of unidentified pipes and could be related to a small UST or valve box. Anomaly B is somewhat elongated and is likely related to buried debris. GPR profiles across these features were inconclusive with regard to their nature. Several additional high EM responses were noted during the course of the survey. These responses appear to be related to surface features such as reinforced concrete walls, fences, sign posts, etc.

**SITE DATA MAP**

EM61 Data: CI = 50 mVolts

In order to further assess the detected features, we recommend that more direct methods be used. Such methods may include the excavation of exploratory trenches/test pits and/or borings.

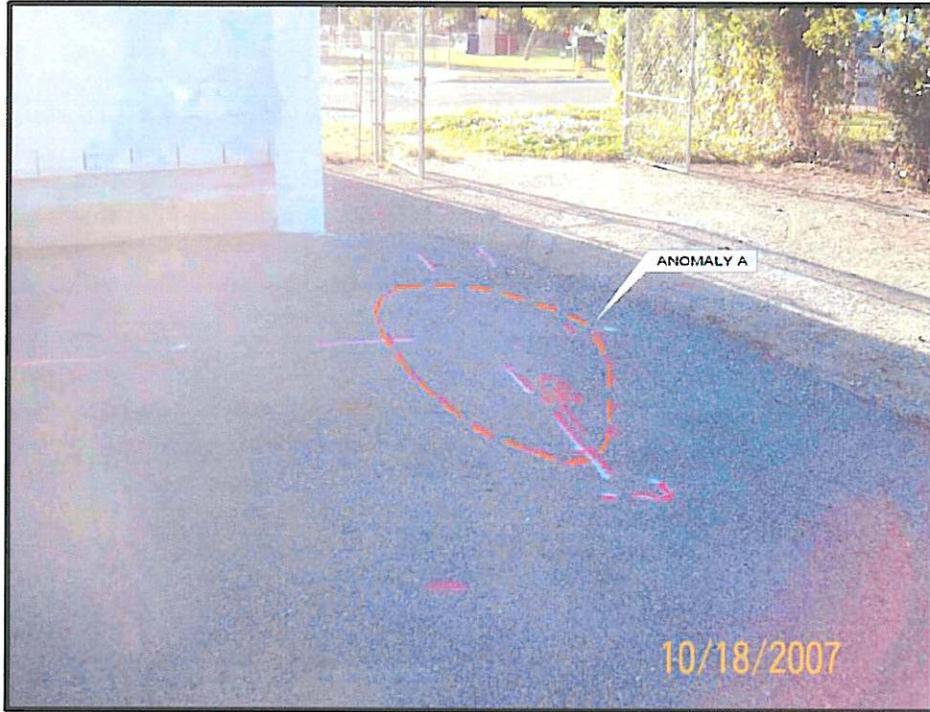
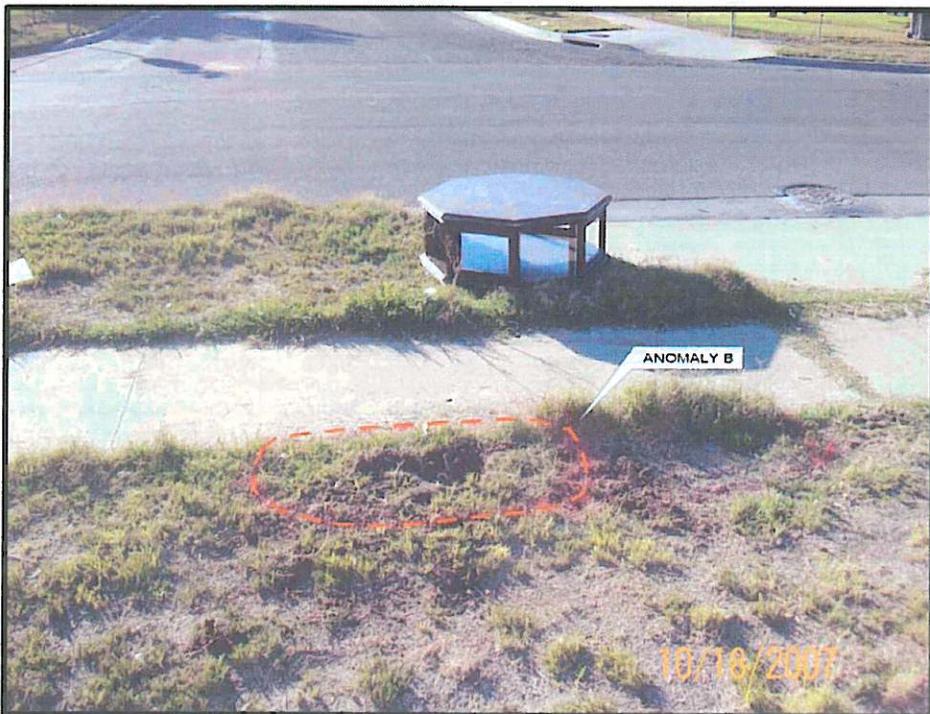
**SITE PHOTOGRAPHS**

5797 Picker Street  
Riverside, California

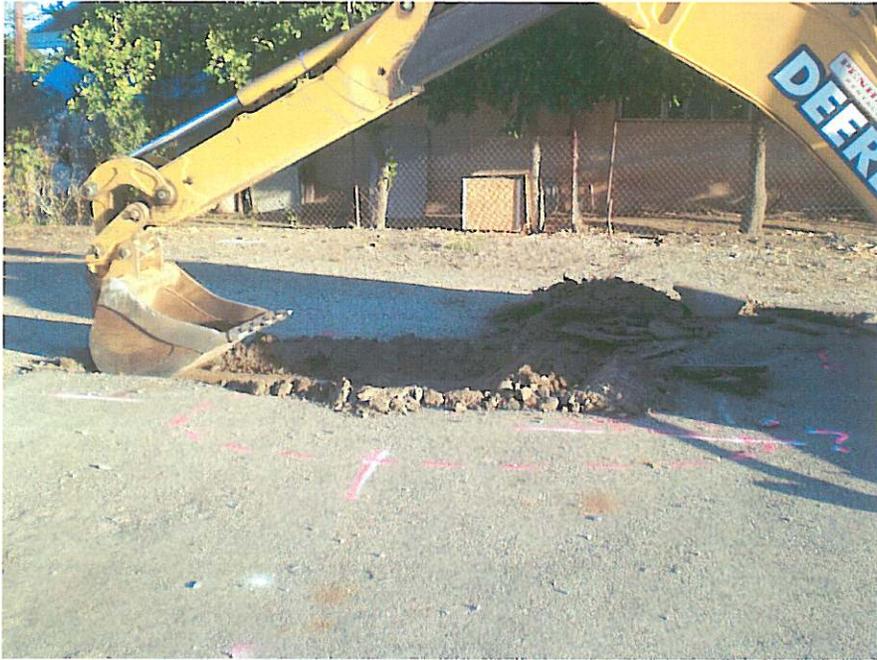
On October 19, 2007, trenching activities were performed under the direction of Converse in the vicinity of anomalies identified in the geophysical survey. Trenching was performed using a backhoe excavator. An approximate 20-foot long by 5-feet wide and 12-feet deep trench was excavated in the vicinity of Anomaly A identified adjacent north of the former Moose Lodge building. Prior to trenching at this location, concrete and asphalt debris were removed from the surface. Trenching was also completed in the vicinity of the metallic anomaly identified adjacent west of the northern portion of the Moose Lodge building (Anomaly B). The trench was approximately 10-feet long by 5-wide and 4-feet deep.

1. View of Trenching Near Anomaly A, Facing North.

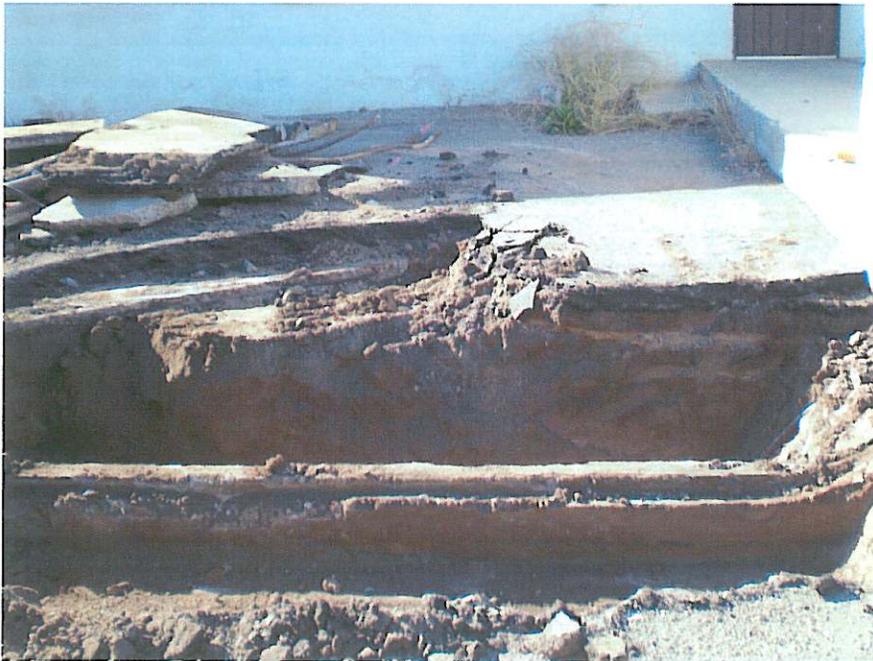
Trenching activities conducted at these locations revealed Anomalies A and B to be steel-reinforced concrete structures and/or debris. No USTs or evidence of USTs were observed.

2. View of Exposed Concrete Wall Structure Near Anomaly A, Facing South.

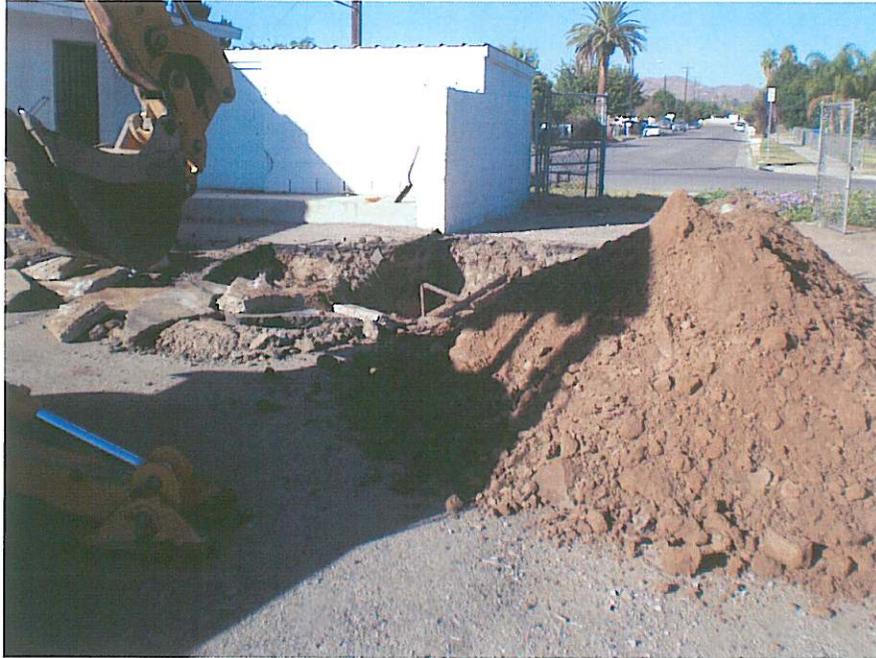
3. View of Soil Pile, Facing West.

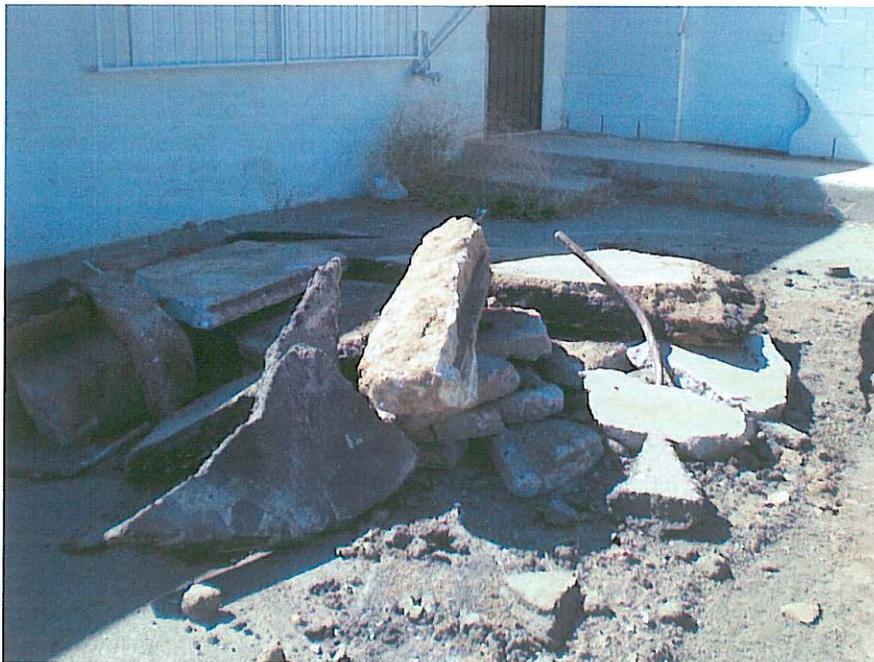
Trenching activities conducted at the Site did not reveal the presence, or any evidence of USTs. The trenching conducted in the vicinity of Anomalies A and B did reveal the presence of steel-reinforced concrete structures and/or debris, but no debris was observed in the other trenches completed at the Site.

4. View of Reinforced Concrete Debris, Facing South.

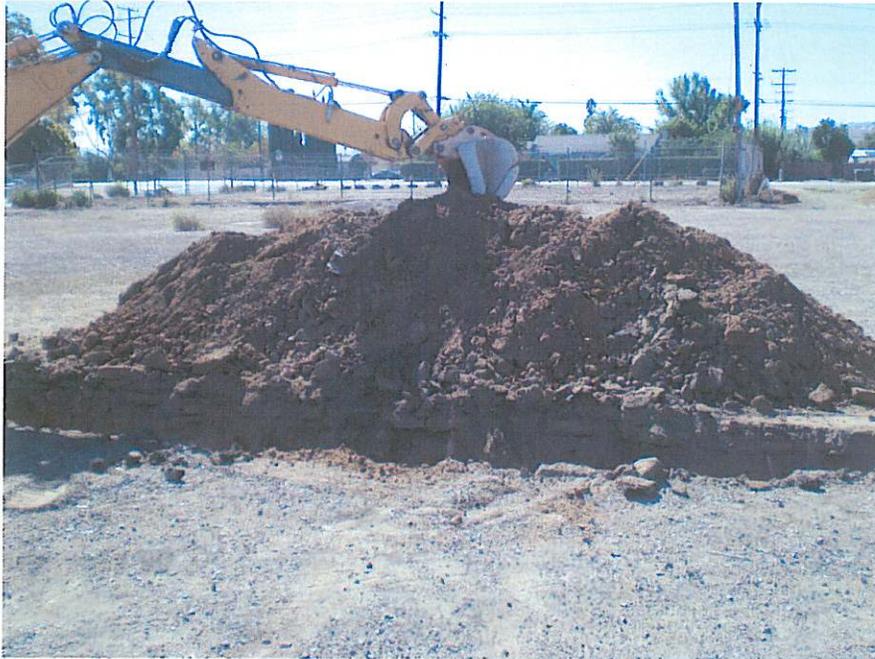
An approximately 20-foot long by 2-feet wide and 10-feet deep trench was excavated adjacent east of a steel-reinforced concrete pad adjacent east of the northern portion of the Moose Lodge. Another approximate 20-foot long by 2-feet wide and 10-feet deep trench was excavated in the middle portion of the Site. Trenching activities conducted at these locations did not reveal the presence of any debris.

5. View of Trenching and Soil Pile on Middle Portion of Site, Facing South.

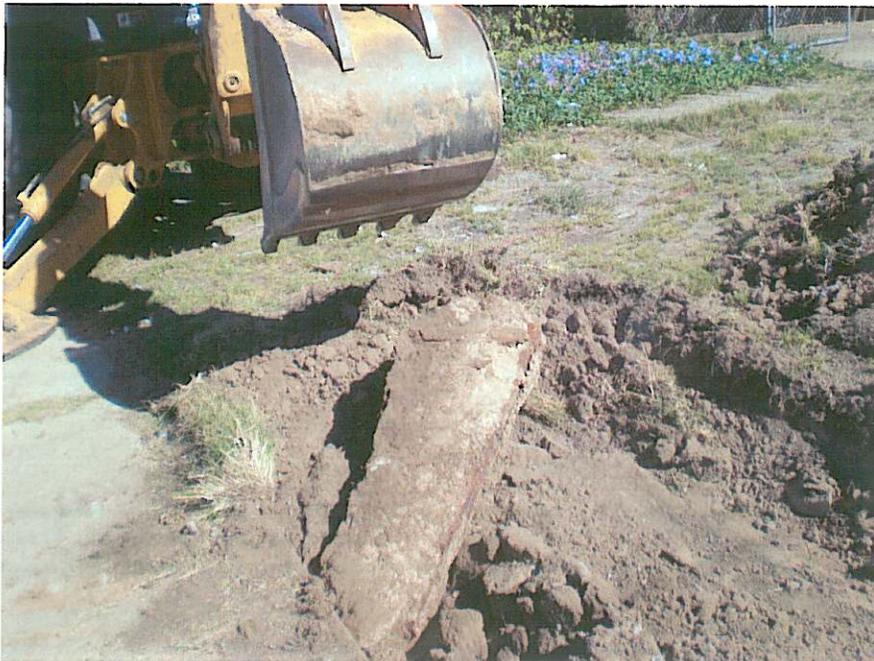
6. View of Trenching and Concrete Debris (Anomaly B), Facing North.
