Harada House

3356 Lemon Street, Riverside, California

LONG RANGE CONSERVATION PLAN/HISTORIC STRUCTURE REPORT

January 11, 2007

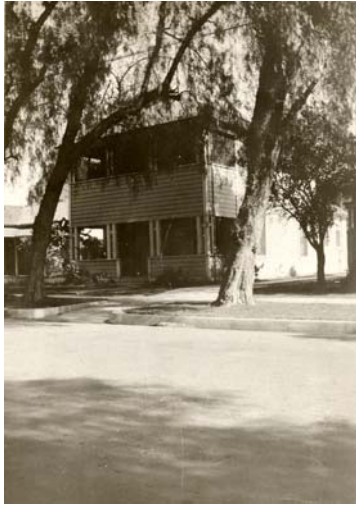
Historic Photograph of Front Yard Showing Landscaping
Riverside Metropolitan Museum Archives

All available archival photographs of the front yard area show plantings lining the porch similar to what is there now. The Harada's allowed the *Pittosporum undulatum* grow to a height that blocked the view both into and out of the house. Another photograph shows a rose trellis on the northwest corner of the house. Missing from this area is another *Schinus molle* (California Pepper) street tree. Photographs show two pepper trees, one on the each side of the driveway in the

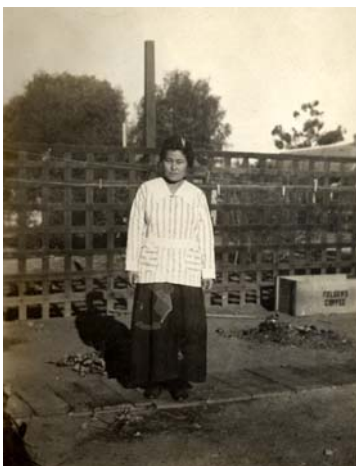
Historic Photograph of Back Yard Showing Landscaping

The back yard has a moderate level of integrity. The original spatial design is clear. Adjacent to the house is concrete paving with a square scored pattern. This is well documented in the photographs and the extant concrete. Remnants of a wooden walkway extend from the paved area in line with the backdoor and currently run through the arbor. The only plant from the period of significance is the *Ipomoea tricolor* (morning glory vine). The main elements missing in the backyard area are the concrete pond and *Prunus sp.*, (apricot) tree mentioned in the interviews with Dr. Harold Harada and Sumi Harada, and the bench and lattice styled fence. The lattice styled fence and backyard bench are well documented; wood remnants stored on the site may be components of the fence. No photographs remain of the pond or *Prunus sp.*, (apricot), or the *Prunus sp.*, (peach) mentioned in letter from Jesse Stebler. Photographs of the narrow area south of the garage show that it was not well kept.

The back yard has the highest level of integrity of all three landscape areas because several of the major elements are still in place and photographs can provide documentation for reconstruction. The pavement area adjacent to the house, the wooden bench, and lattice styled fence, wooden walkway are well documented. The existing *Ipomoea tricolor* (morning glory vines) can be reestablished on the lattice fence once it is in place. If this is not possible after construction new vines can replace the old vines, but the original plants should be retained if feasible. A planting bed along the fence line in front of the vines approximately two to three feet wide with iris and roses should be reestablished.

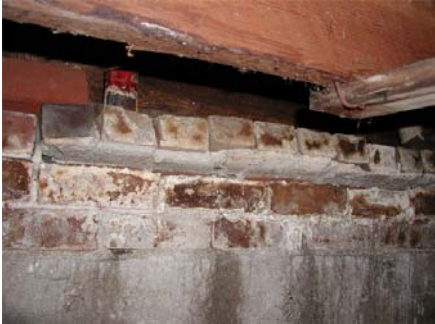
Brick and Concrete Wall in Basement

Exterior features as well as exterior surfaces and their treatment (modeling, tooling, bonding patterns, joint size, and color) are important in defining the historic character of the building. Buildings that have concrete exteriors or masonry detailing may exhibit the following conditions and, therefore, require maintenance and rehabilitation: impact damage at building corners; cracks; damage due to spalling; damaged ornamentation on friezes and columns; peeling paint; inappropriate patching methods; inappropriate treatments such as sandblasting which exposed softer inner materials; and repointing of brick mortar joints by inappropriately composed and colored materials applied with non-matching tooling.

- 1 Repair walls and other features where there is evidence of deterioration such as spalling, damp walls, or damaged concrete or masonry.
- 2 Sandblasting shall not be used to prepare or clean exterior concrete or masonry. Blasting by any media, including liquids, shall not be used unless it can be demonstrated that no surface material is removed by application. Application of any liquid media shall not exceed a pressure of 150 pounds per square inch measured where the liquid leaves the application nozzle. Use non-abrasive tools, such as natural bristle brushes; do not use abrasive or gouging tools, such as wire brushes and scrapers.

- 3 Repair concrete or masonry features by patching, piecing-in, or consolidating the concrete or masonry. Repair may also include the limited replacement in kind, or with compatible substitute material, of those extensively deteriorated or missing parts of concrete or masonry features when there are surviving prototypes, such as brackets, pilasters or chimneys.

- 7 | Repointing of historic masonry mortar joints shall utilize mortar mixes formulated to match the composition and color of historic mortar based on laboratory analysis and reporting of the composition and color of the matrix and aggregate in the historic mortar. Tooling of mortar repairs and restorations shall match historic mortar tooling as identified by the HSR or a qualified preservation architect or building materials conservator. Removal of deteriorated or inappropriate mortars prior to repair shall be accomplished with the utmost care, preferably using hand tools, and shall cause no damage or change to the historic masonry.

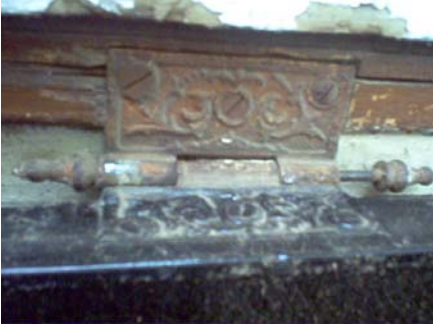
Decorative Hinge

Architectural metal features may require rehabilitation and maintenance due to weathering and corrosion.

- 1 Identify, retain, and preserve architectural metal features such as columns, capitals, window hoods, canopy cladding or fascia, stairways, light fixtures or gates that are important in defining the overall historic character of the building. Also identify and preserve their finishes and colors. If originally painted, it is recommended, but not required, that the architectural metals be repainted with colors that are historically appropriate to the building.

- 2 Clean architectural metal, when necessary, with gentle non-abrasive cleaning methods to remove corrosion. Sandblasting shall not be used to clean historic metal surfaces.

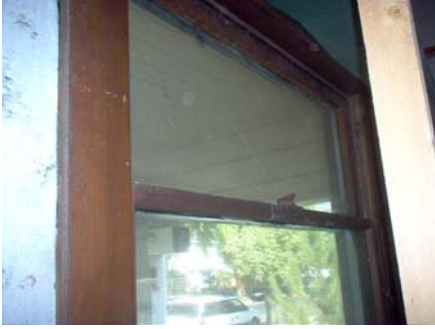
Ground Floor Window

The type and size of window openings are extremely important in defining the overall historic character of a building. Their retention, protection, and repair should always be carefully considered when planning rehabilitation work. Wood windows may deteriorate from hard use, warping, or settling, and metal windows are susceptible to water damage. Glazed openings may shatter.
