City of Riverside Public Works Department

Update of the Integrated Master Plan for the Wastewater Collection and Treatment Facilities

APPENDIX 7C: ACORN/ARLANZA TRUNK SEWER ANALYSIS

FINAL | June 2019

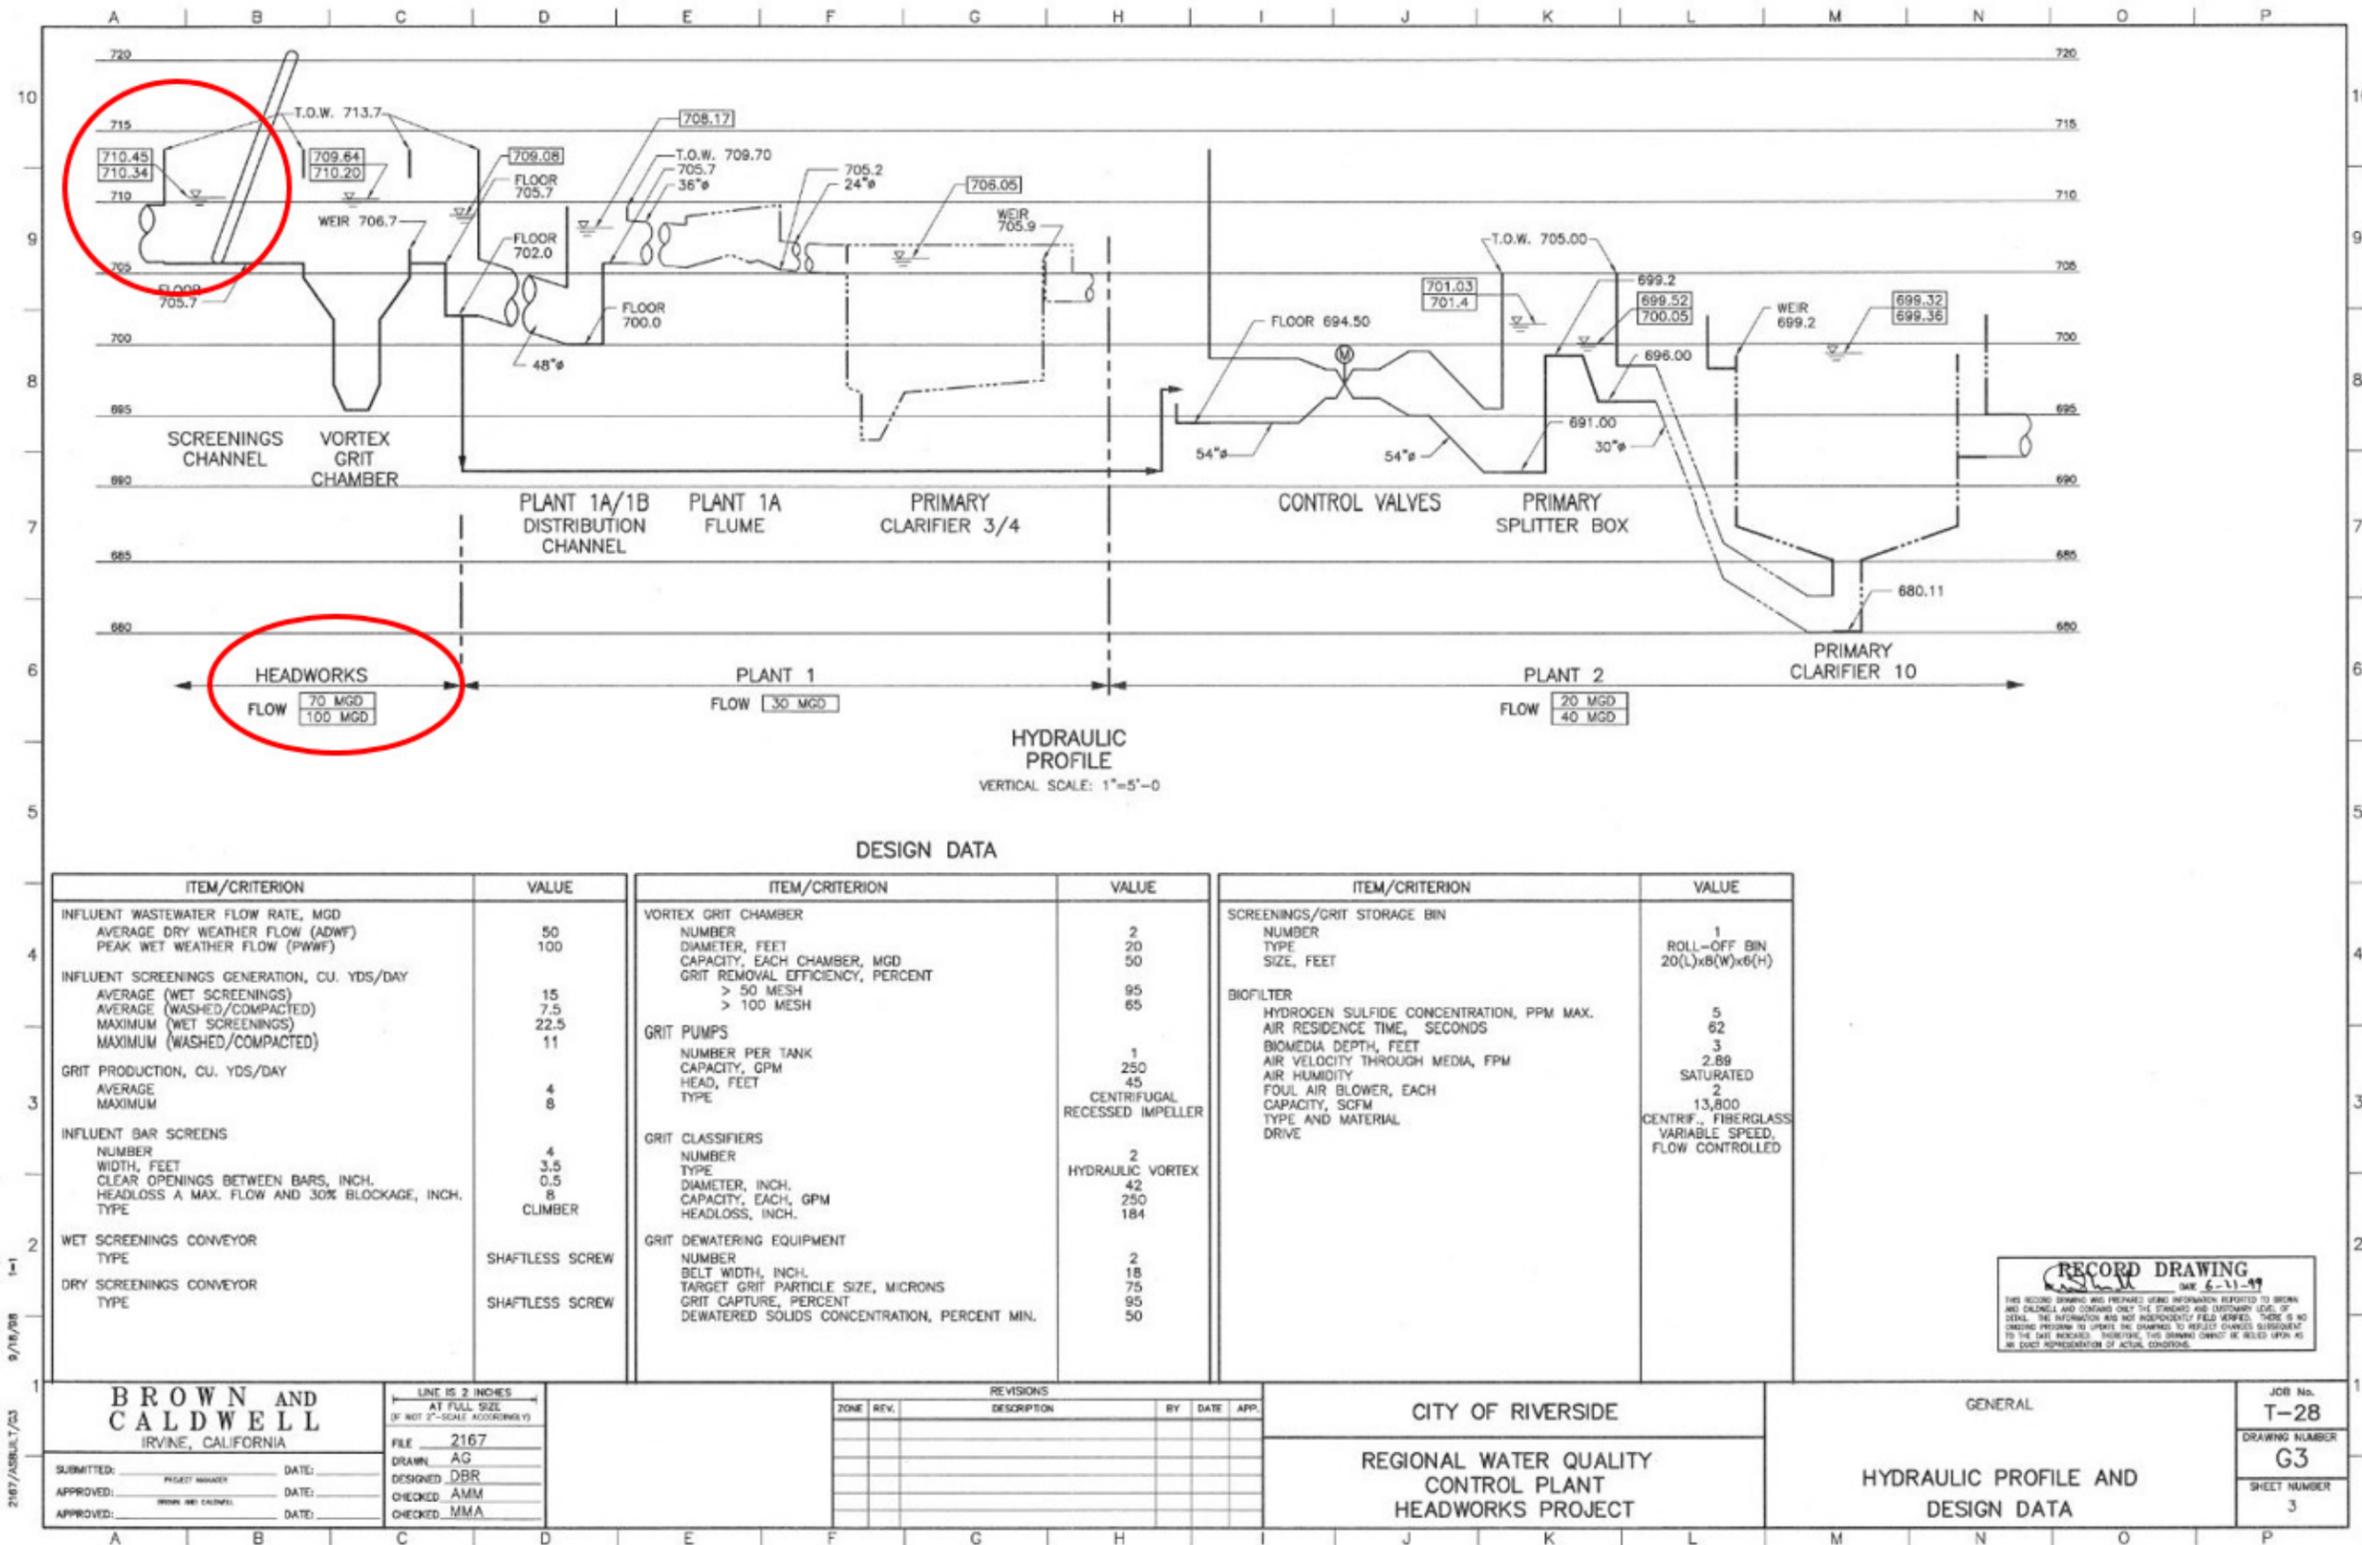
Figure 3 RWQCP Hydraulic Profile

Record drawings were reviewed in order to understand the hydraulics conditions and flow levels at the RWQCP headworks. According to record drawing, the City's RWQCP headworks was designed to maintain a HGL of 710.34-feet at an influent flow rate of 70 mgd and maintain a HGL of 710.45-feet at an influent flow rate of 100 mgd. Under these flows the A/A trunk would surcharge by approximately 6-inches above the pipe crown elevation of approximately 709.86 feet. A copy of the City's RWQCP hydraulic profile is shown on Figure 3.

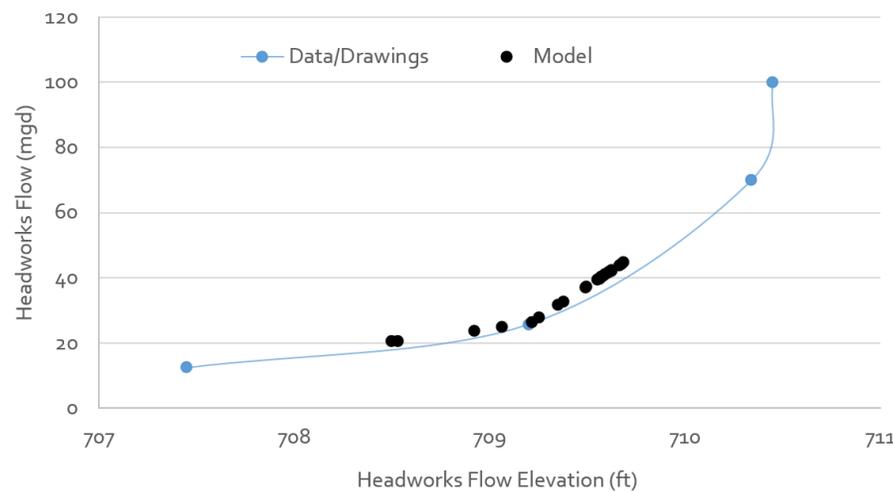
Figure 5 Model Headworks Depth versus Flow Relationship Curve

The City collected flow and depth measurements at the meter station and headworks at two concurrent times on May 4, 2018. Table 1 summarizes the data collected by the City. The collected data was used to update the hydraulic model's depth (or stage) versus flow relationship curve at the simulated collection system headworks and is shown on Figure 5. Note that the initial depth versus flow relationship curve was based on record drawings. Figure 5 also compared model headworks flow elevations at varying flows with the depth versus flow relationship curve. The modeled depths match well compared to the developed curve.

The modeled results at the meter station were compared to the measured depth. Measurements 1 and 2 were used to confirm the updated depth versus flow relationship curve. For each event the measured A/A trunk sewer flow was loaded at the A/A junction structure, while the difference between the measured headworks and A/A trunk sewer flows was loaded upstream along the Santa Ana Sewer Line. The modeled meter box depth matched well to the measured results for measurements 1 and 2. Figure 6 shows the HGL of the A/A trunk sewer with a flow of 12.8 mgd. The level HGL indicates that the backwater effects are caused by the headworks, represented by the outfall in the model. Therefore, the surcharging is a result of the backwater effects caused by the hydraulic grade conditions at the headworks.
