THE PURPOSE OF THIS RECORD IS TO DOCUMENT THE PERPETUATION OF FOUND MONUMENT(S) PURSUANT TO THE PLS ACT SECTION 8771. NO CLAIM IS MADE REGARDING THE CORRECTNESS OF THE POSITION(S) OF SAID MONUMENT(S), NOR THE DIMENSIONAL RELATIONSHIP TO STREET CENTERLINES OR PROPERTY BOUNDARIES.

12-ALL-160

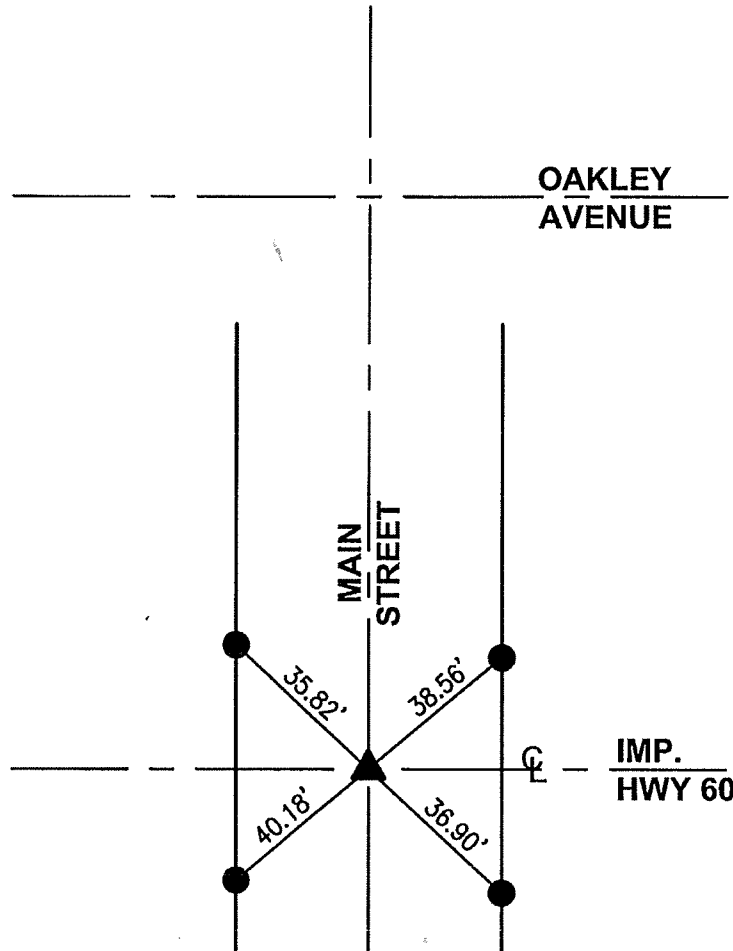
UNABLE TO VERIFY  
CENTERLINE POSITION

▲ FD. 3" PUNCHED BRASS DISK NO DESC. DOWN 0.2' NO REF., POSSIBLE POSITION OF STD. C.D.H. DISK PER R-1, UNABLE TO VERIFY CENTERLINE POSITION BEFORE CONSTRUCTION. SET MAG NAIL & WASHER "LS 5411" AT SURFACE PER TIES HEREON, UNABLE TO VERIFY CENTERLINE POSITION AFTER CONSTRUCTION.

● FD. L/T IN T.C. NO REF.
